TECHNICAL BULLETIN INDEX
Sorted by Bulletin Number
04/03/86

BULLETIN NO: II:1

PRODUCT: 26-4001/2 Model II

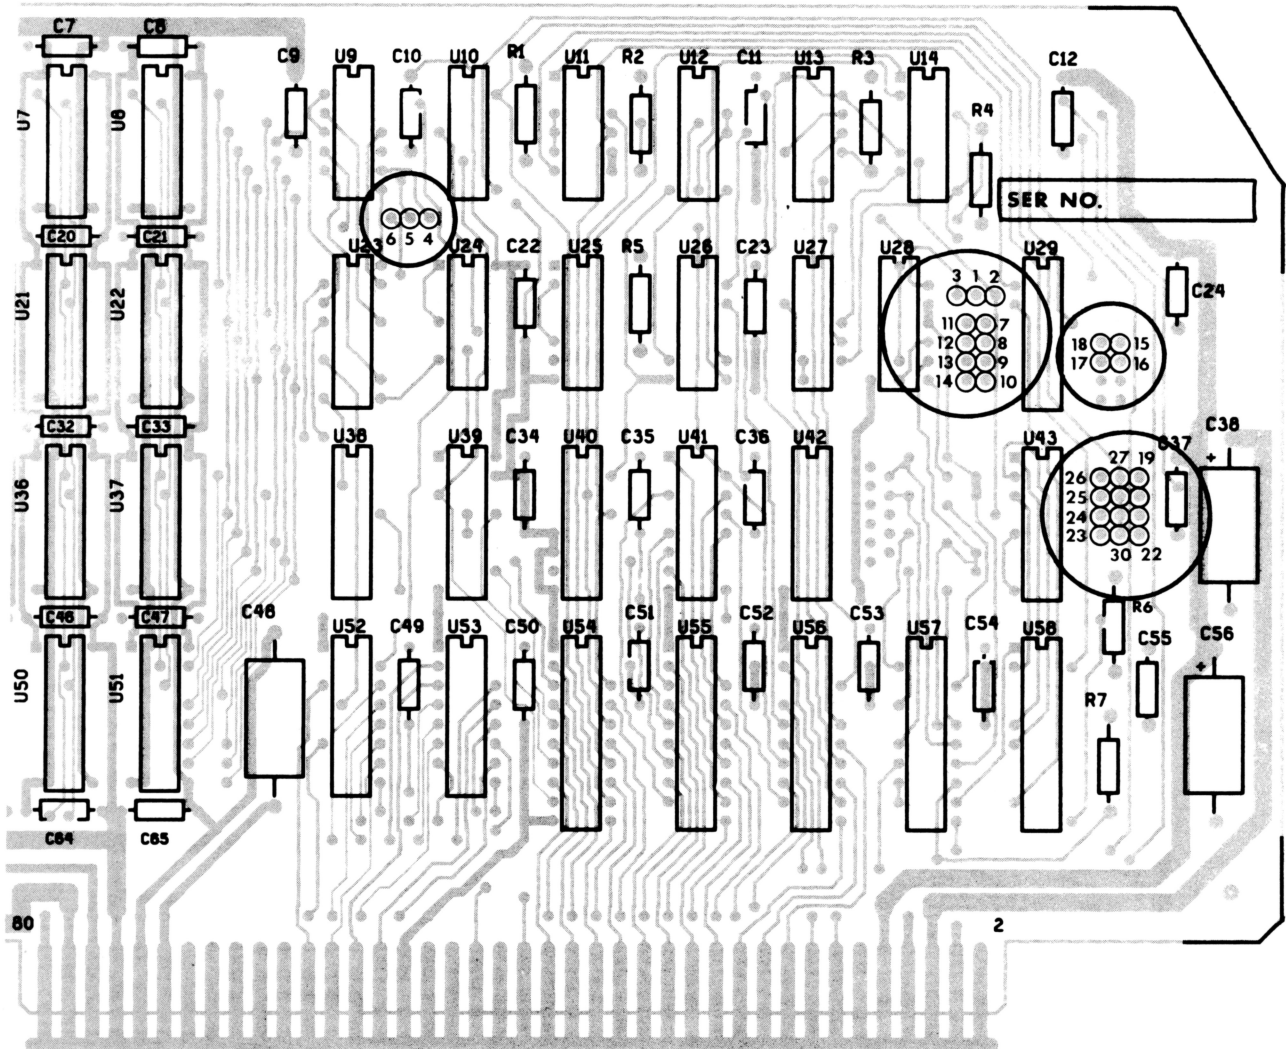
Figure 1

- 1-2 Pulls up an input to U27 that was floating
- 5-6 Pulls up an input to U9 that was floating

Use MEMII Diagnostic to check each memory board for correct jumpering and proper operation.

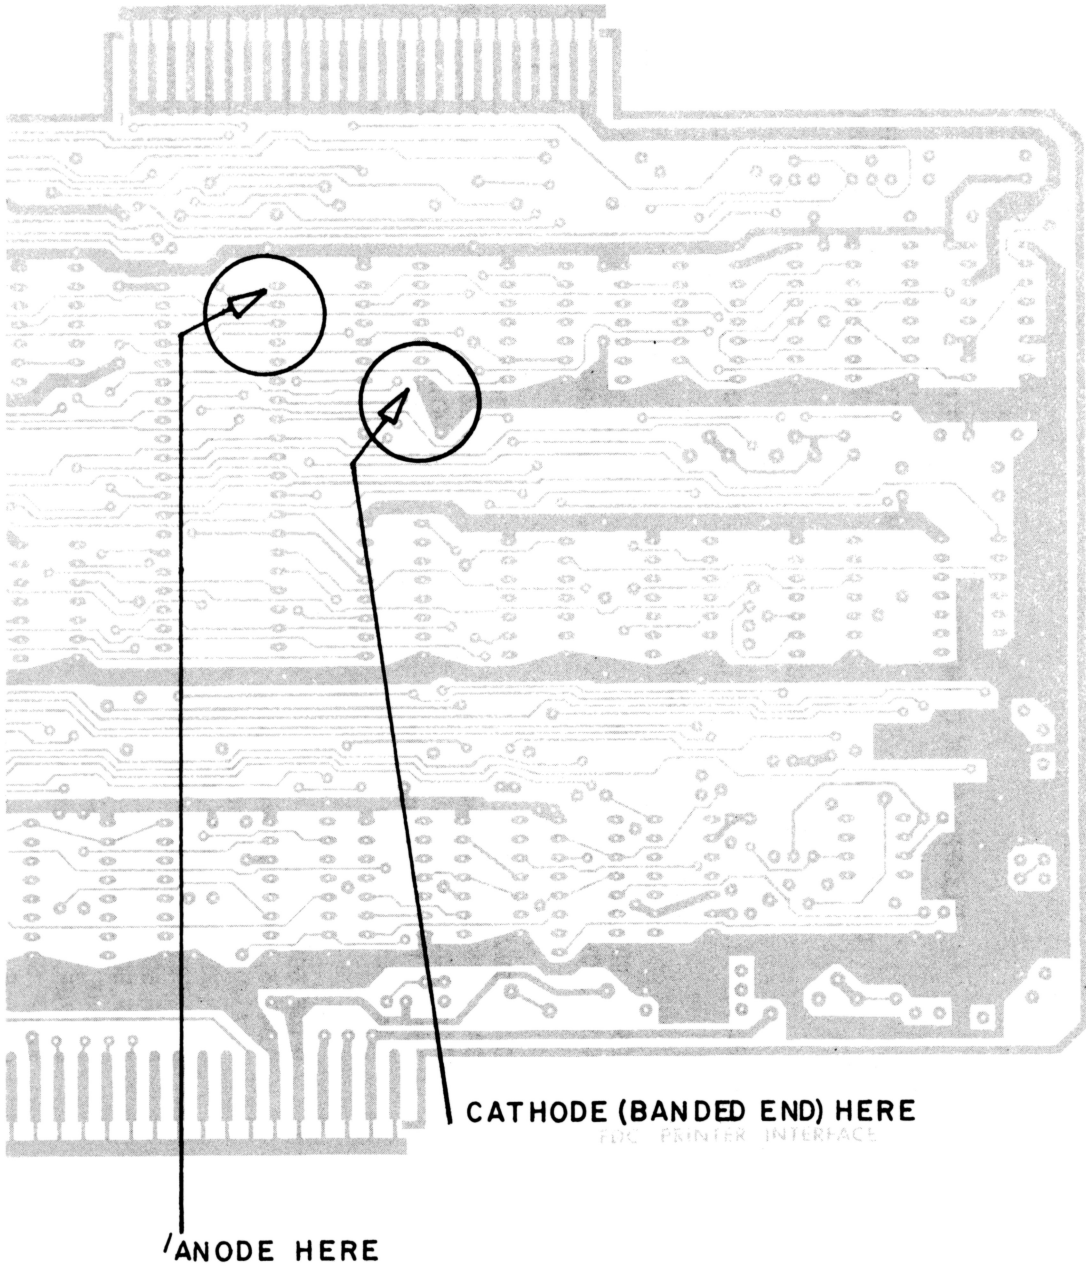
Figure 1

PURPOSE: To correct thermal failure of FDC IC (U6) causing Read/Write errors, and other intermittent disk I/O failures.

DISCUSSION: Early FDC chips developed thermal failures causing disk I/O failures and Read/Write errors. To correct this problem a 2.7V Zener diode **MUST** be installed from U6 Pin 1 to U5 Pin 7. On new and factory repaired assemblies this change will already have been installed.

PROCEDURE: Check to see if this modification has been done, if not, install diode as per Figure 1. Be sure to use sleeving for insulation of leads to prevent shorts. This diode can be ordered from National Parts using part number ADX-1382 and catalog number 26-4001.

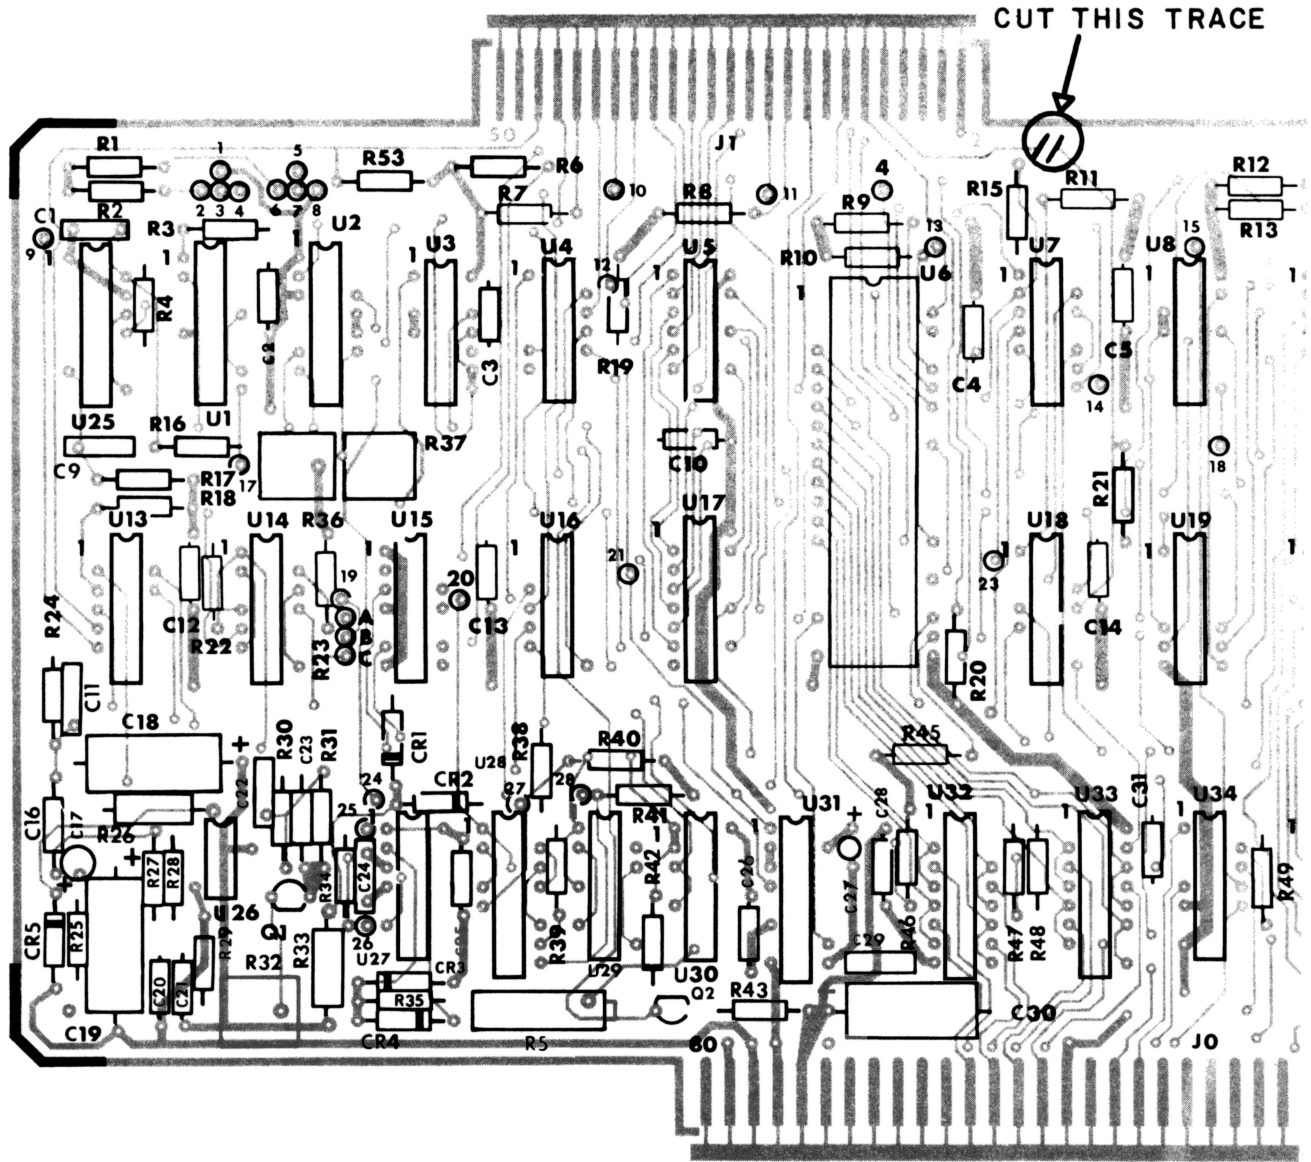
Figure 1

NOTE: This modification will cause the PIO SYSTEM test to fail. In cutting this trace you are removing a signal path connected to PIO channel A pin 14 through an inverter IC U18. This signal is A1 from the PIO. The PIO SYSTEM test will output a write out of channel B and then read the data back in channel A. With this trace cut, channel A will have bit A1 stuck high and thus the incorrect data read back in will produce an error in the SYSTEM test. The fact that this error will occur after this modification needs to be noted by the technician and therefore the SYSTEM test should be run before the modification is done.

PROCEDURE: Locate and cut the trace connected to pin 10 of the disk drive connector on the FDC board (Refer to Figure 1).

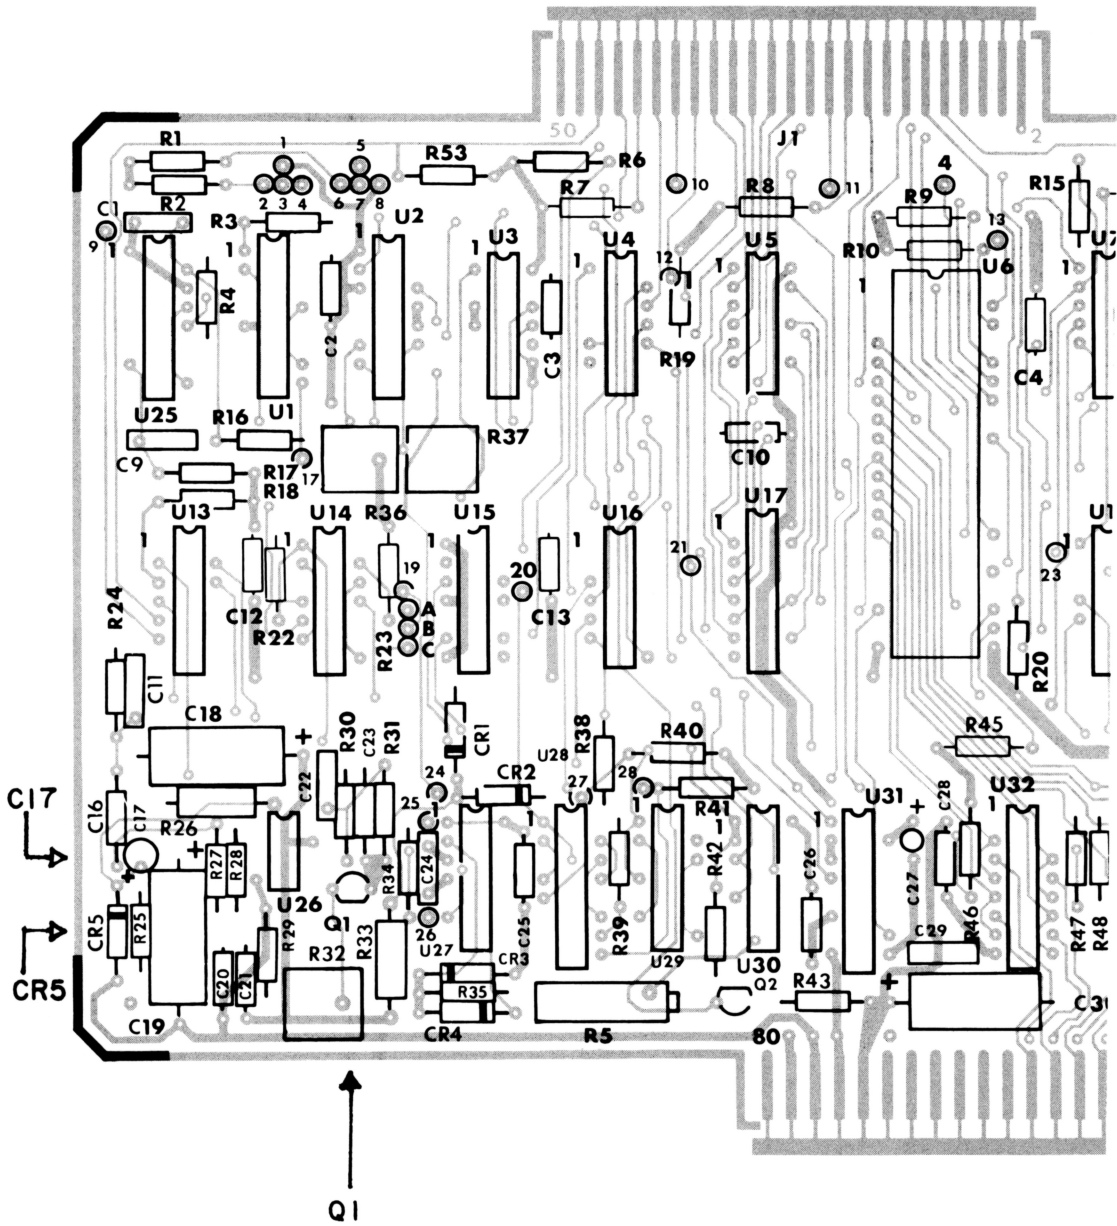
Figure 1

DISCUSSION: Early FDC boards had a problem with C17 installed backwards. Rev A boards were not marked with polarity. Rev B boards and early Rev C boards were marked with the polarity backwards. This problem was corrected on later Rev C boards. C17 is a .47 ufd tantalum capacitor with a 33V rating. Installed backwards it will eventually break down due to approximately -6V across the capacitor. Note that CR5 is referenced to -12V. This capacitor installed backwards can cause intermittent problems and will eventually cause circuit failure. Over a period of time the capacitor will smoke causing CR5 and possibly Q1 to be damaged.

PROCEDURE: Check C17 on all units in for service to insure the positive(+) lead is going to ground. The most accurate method of checking this is by actually checking with an ohm meter continuity between the positive lead of C17 to ground. If capacitor is installed backwards replace with a new .47ufd tantalum capacitor(ACC-474MGTP). Do not just turn the old capacitor around as it has started degrading and life expectancy shortened.

If the capacitor actually smoked then you must replace it and the diode CR5 (ADX-1279). Also check Q1, a 2N2222A transistor (AMX-4263), because it may have been damaged also, replace if necessary.

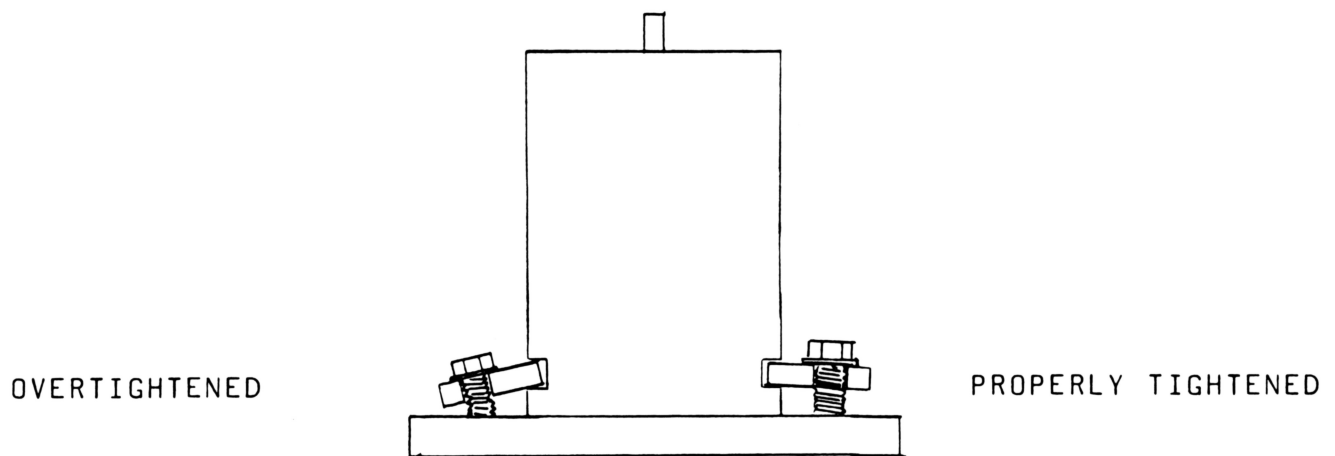
FIG. 1

DISCUSSION: After aligning Head Radial DO NOT OVERTIGHTEN bracket screws when securing the stepper motor. Excessive tightening will cause bracket and screws to bend and eventually damage the screw holes in the stepper motor plate, making proper alignment almost impossible.

PROCEDURE: After Head Radial Alignment tighten bracket screws only enough to secure stepper motor. If the stepper motor cannot be secured without excessively bending the bracket (Refer to Figure 1), or if the screw holes in the plate are damaged, replace the drive chassis.

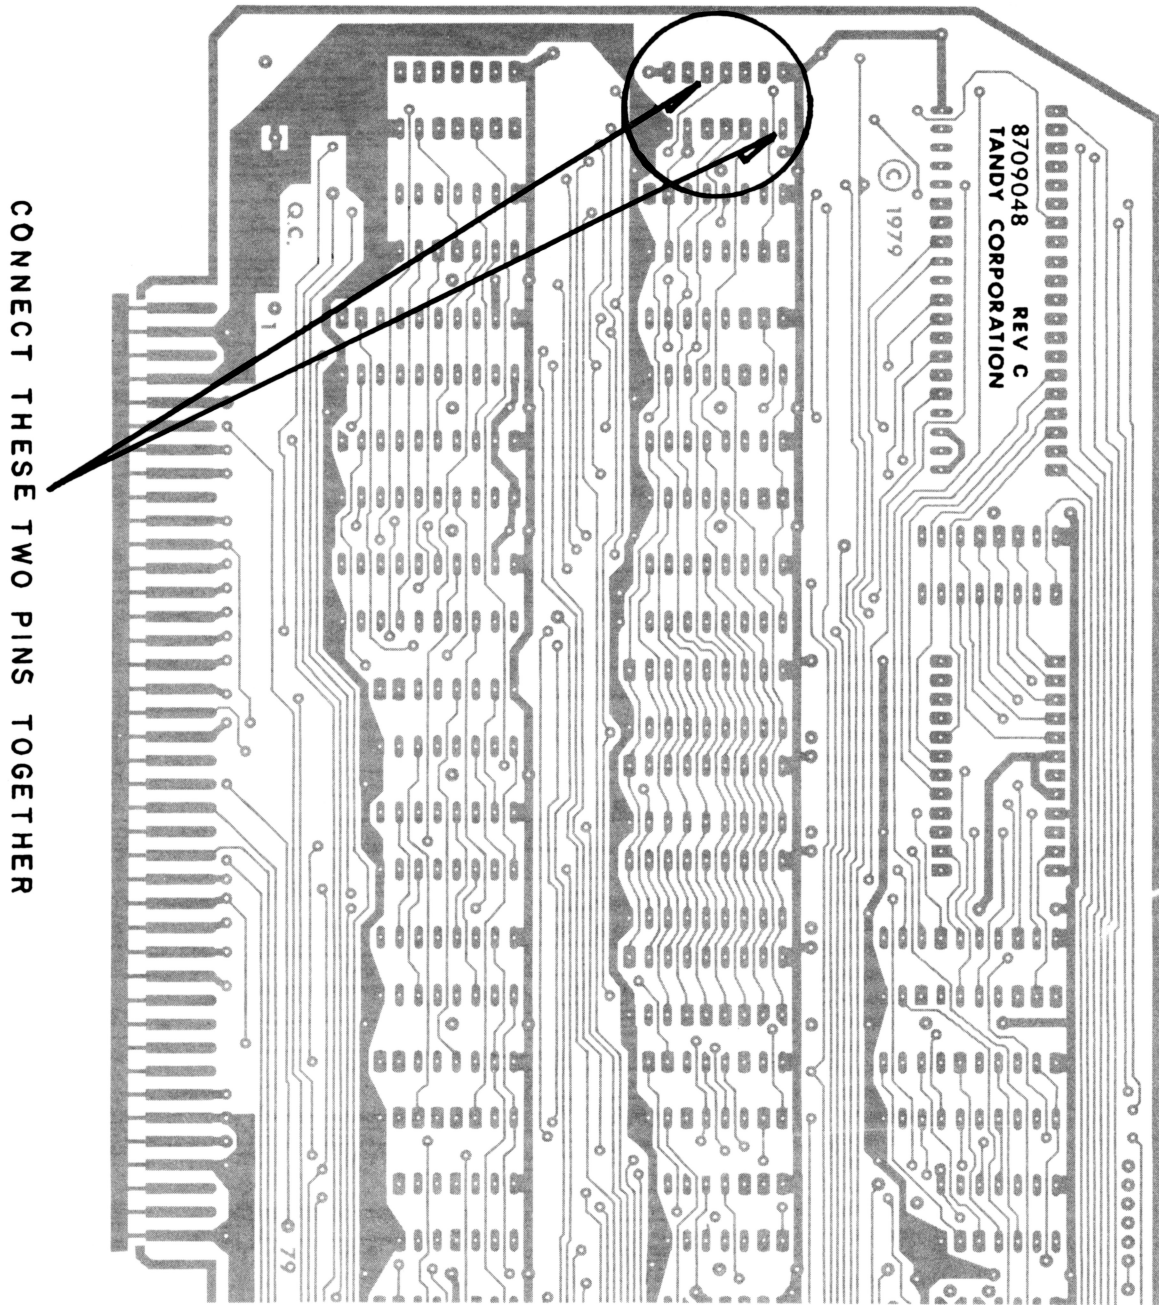
Figure 1

DISCUSSION: Rev A and B VDG boards have a problem with dual addressing. Addresses FC through FF are decoded on the VDG board for use by the Model II. There is an image of these addresses from 7C through 7F. Most systems will not have hardware port mapped at these addresses so no problem will appear. The only time a problem may arise is if a system has hardware installed that is port mapped in the range of 7C through 7F. This problem was corrected on Rev C VDG boards.

PROCEDURE: Whenever a Rev C VDG board is replaced with a Rev A or B VDG board jumper pin 1 to pin 10 of U27 on the Rev A or B board to insure no addressing conflict of the VDG board (Refer to Figure 1).

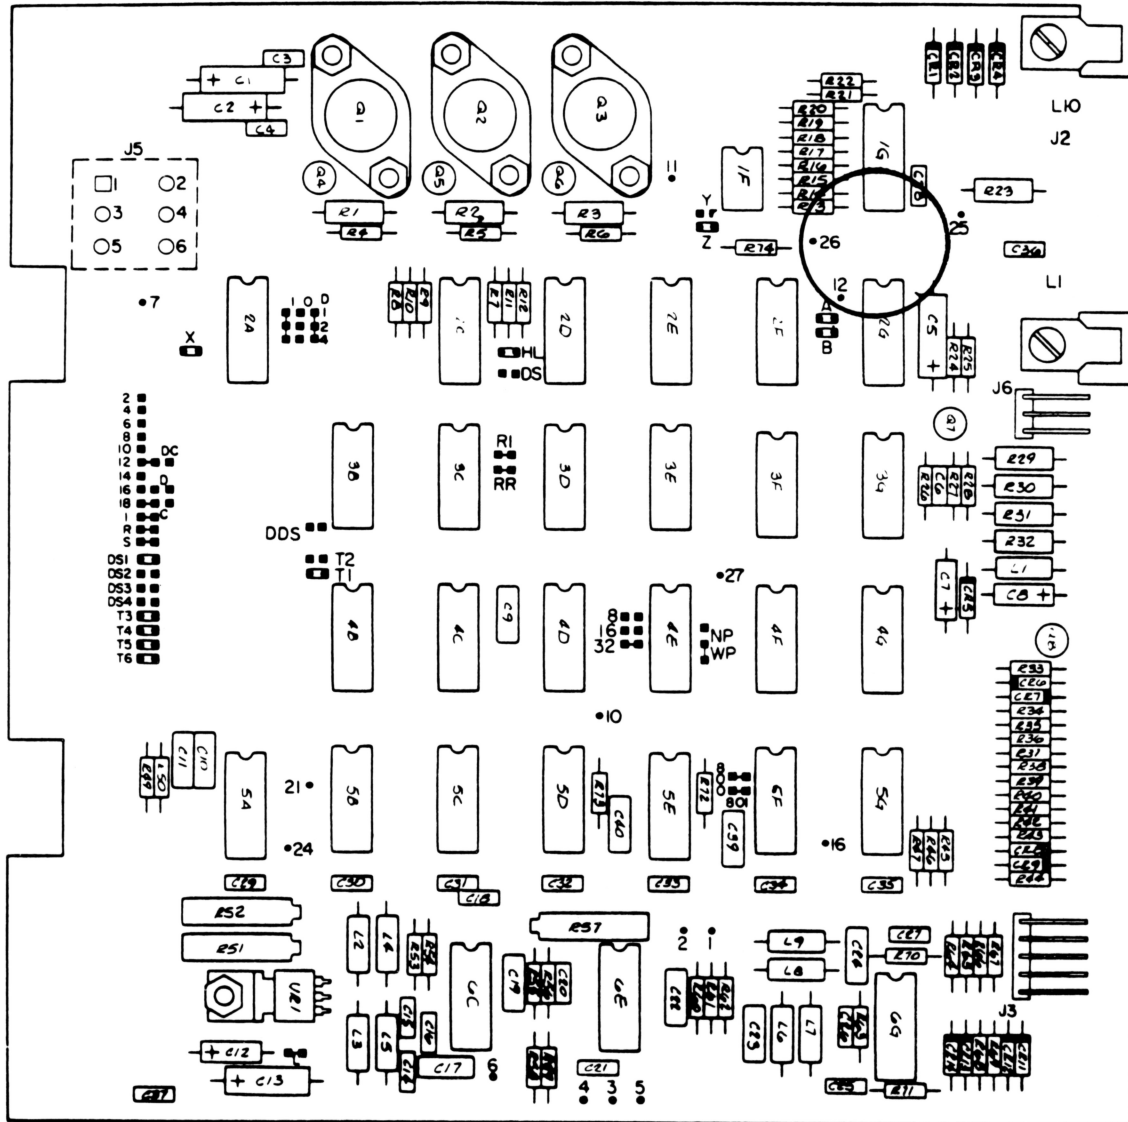
DISCUSSION: To correct booting errors the Ready line on the Shugart discrete logic board should be bypassed to ground with a .01ufd disc capacitor. All discrete boards should have this capacitor installed as a preventive measure. Any system that exhibits an unexplained booting problem not related to a hardware fault should be checked for this capacitor. This is now being done at the factory to new discrete boards. This capacitor is NOT to be added to Shugart LSI logic boards.

PROCEDURE: Check Ready line for .01ufd installed to ground. If capacitor is not present install .01ufd disk capacitor to ground (Refer to Figure 1).

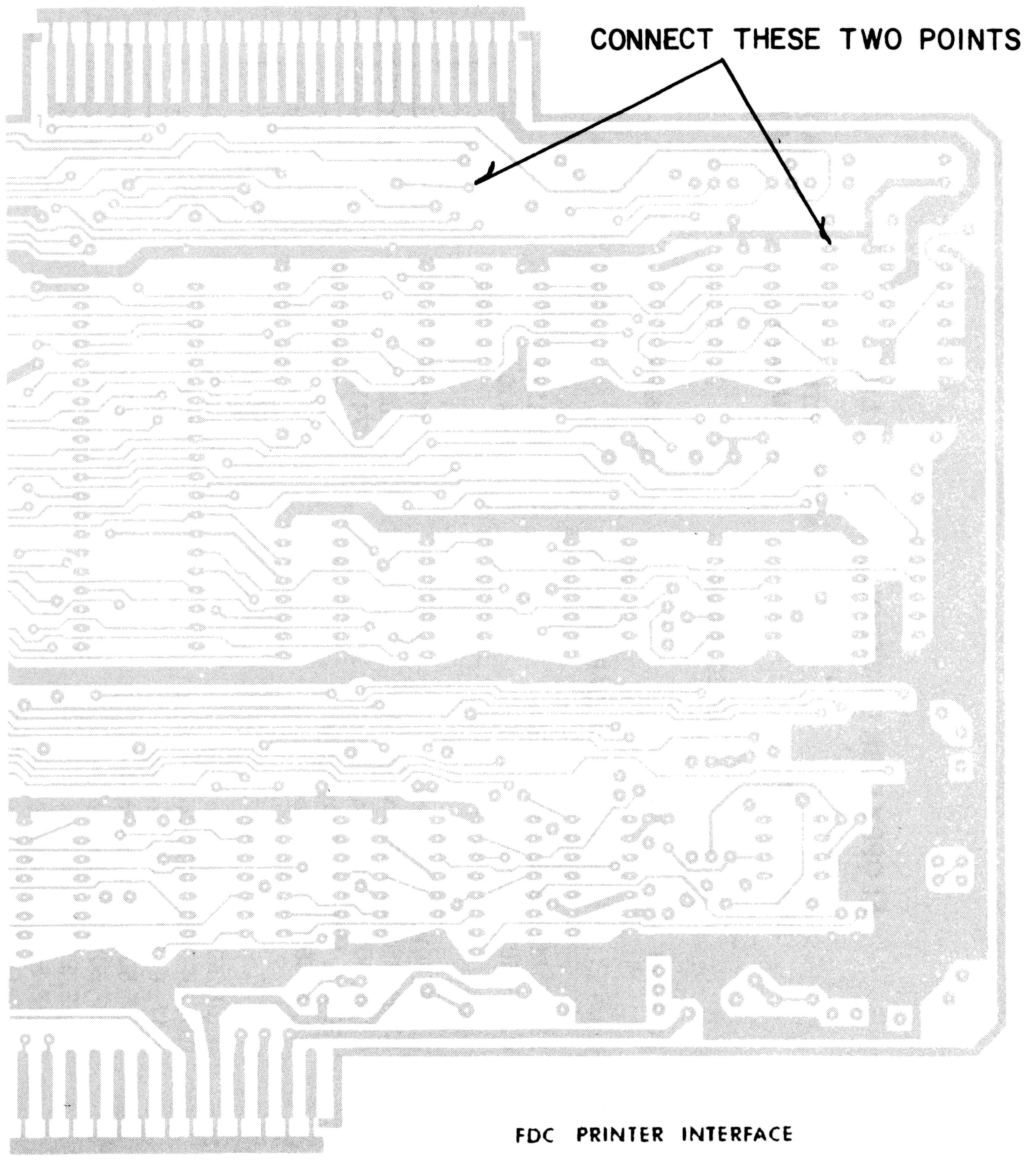
FIG 2

PURPOSE: To correct problem of not being able to format past Track 43.

PROCEDURE: On unmarked, Rev A, or Rev B boards make sure the "one shot" modification has been installed (Refer to Technical Bulletin II:9), or that long jumpers are installed on the back of the board running to U37. Disregard this step on Rev C and D boards as they have this modification incorporated into their circuitry. On ALL revisions of the current board with a SY1791-02 FDC chip installed, add a jumper wire on the back side of the board from U1 pin 1 to the trace connected to TP10 (Refer to Figure 2).

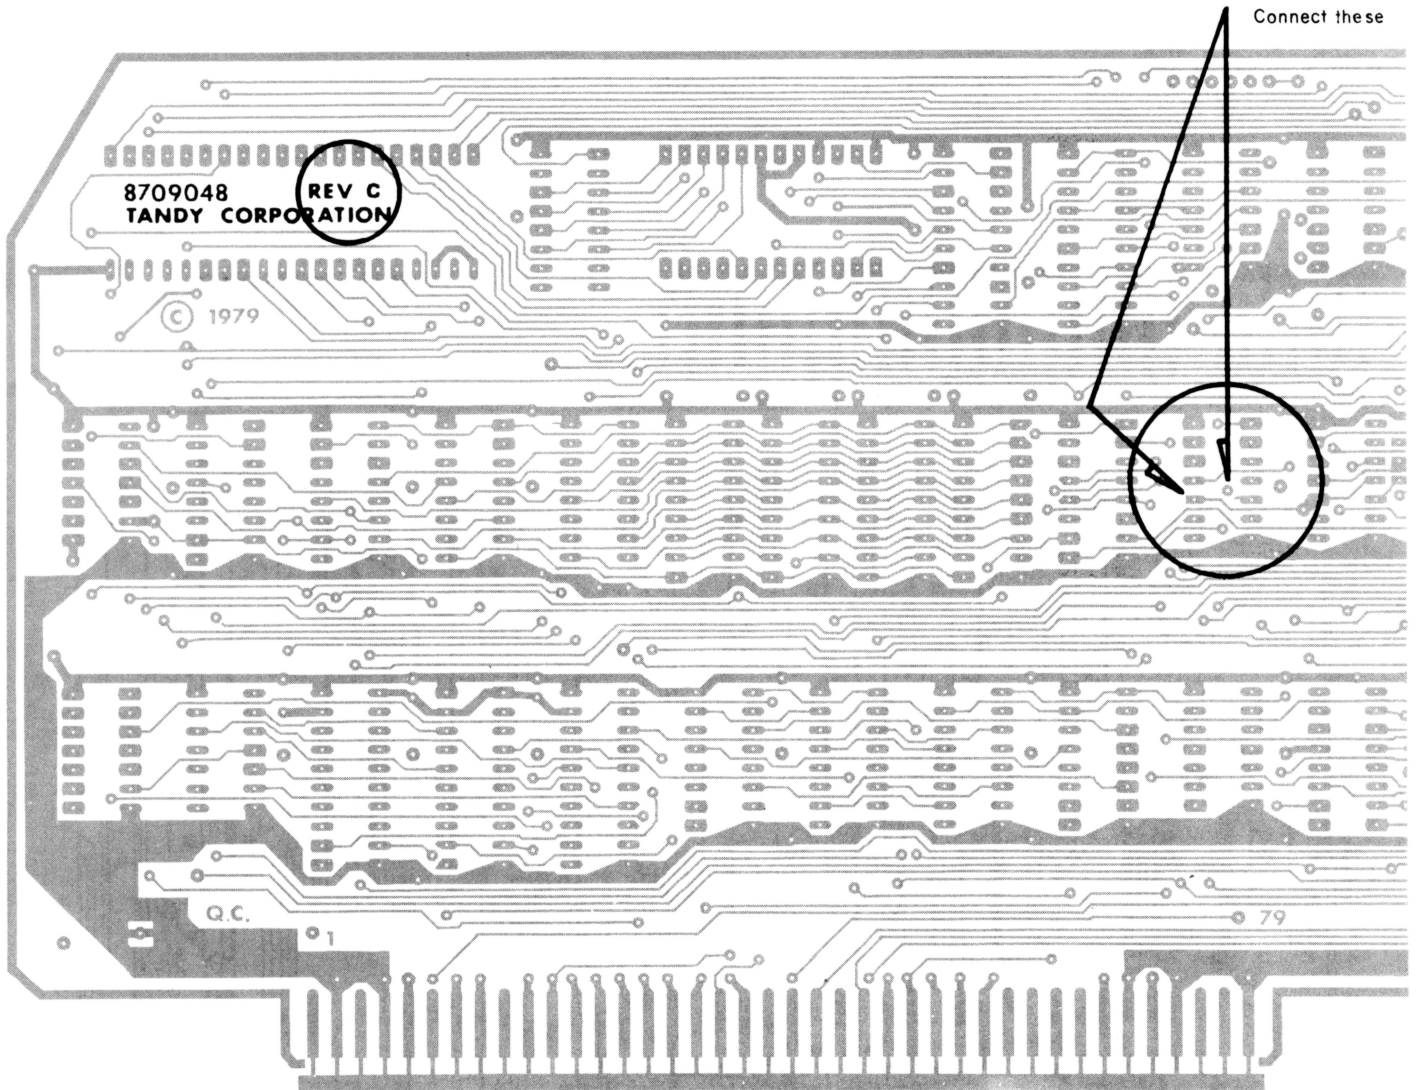
Figure 1

DISCUSSION: On Rev C VDG boards made by Lika there is a trace missing to the clear line on the latch (U17) that generates KBIRQ*. This can generate random interrupts that may or may not be fatal. To correct this problem a jumper is added to correct the missing trace which is a pullup to the clear line of U17. To identify the board as being manufactured by Lika, look for the Rev C marking on the solder side of the board under the 6845 chip and by LEI etched also on the solder side the crystal. This is the ONLY board to which this fix applies.

PROCEDURE: On the solder side of the board there is a feedthru located beneath the middle of U17 that is not connected to anything. Run a short piece of wire from that feedthru to U17 Pin 10 (Refer to Figure 1).

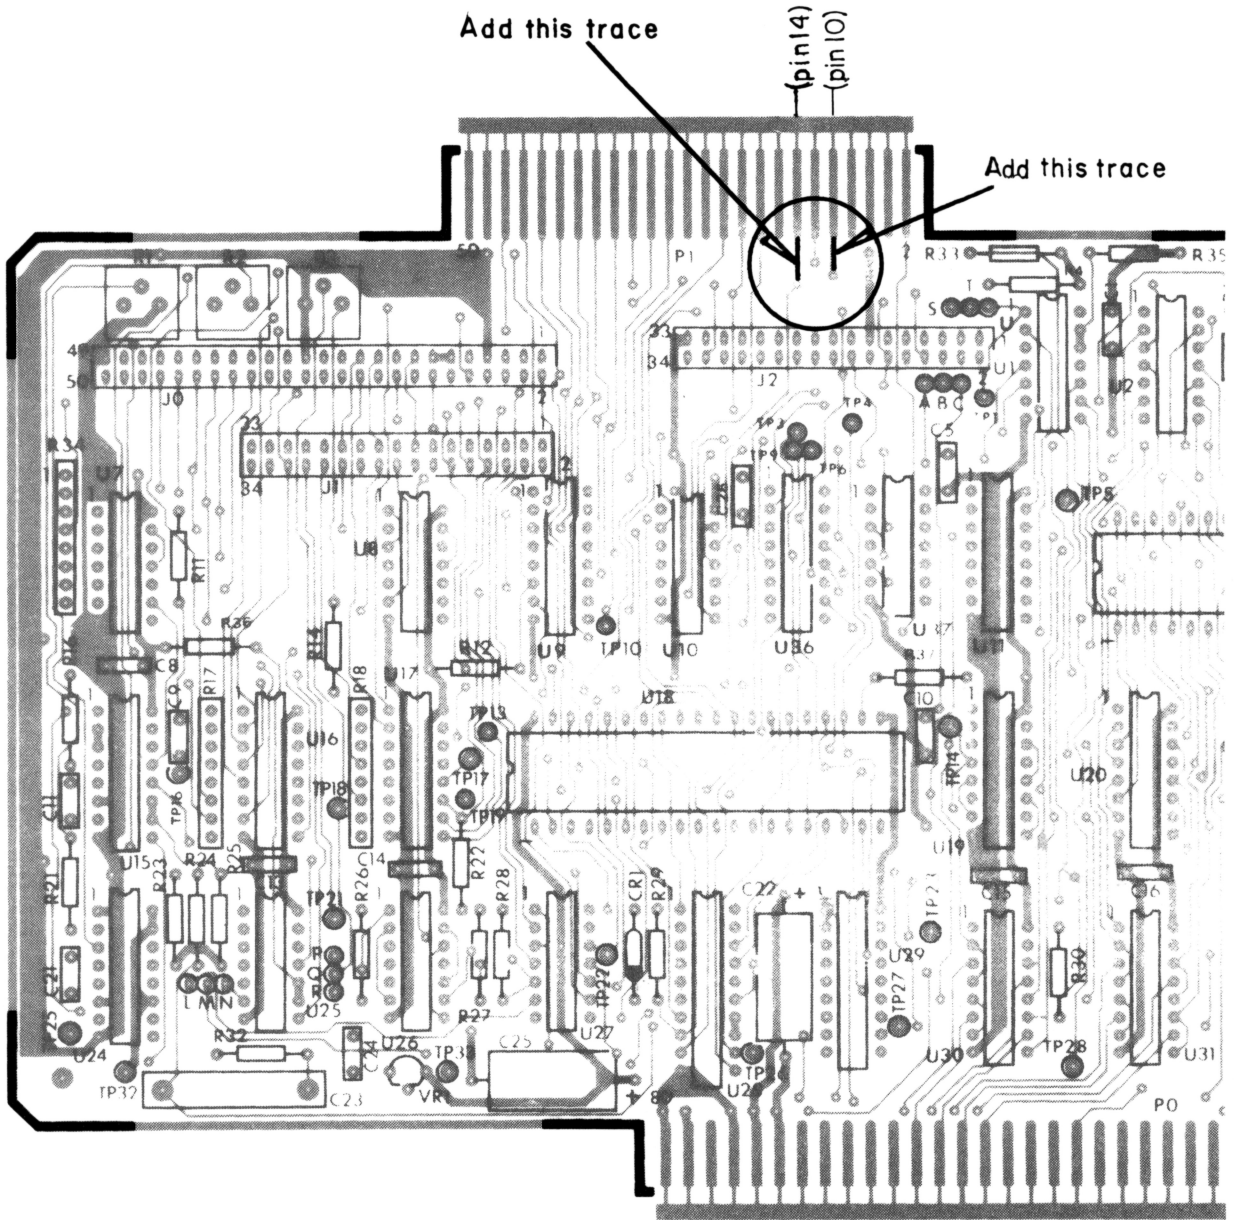
DISCUSSION: The trace that supplies the side select signal to the external drive connector on the Late Design FDC board (Rev Blank) is missing. Also, on some boards the trace that supplies the TWOSIDE* signal from the external drives to the FDC board is not present. Without these traces double sided drives cannot be used externally with the computer and will cause a problem with some diagnostics.

PROCEDURE: Refer to Figure 1 for the location of these traces. Run a jumper from pin 14 of connector P1 to the feedthru on the PCB that is directly in from the connector. Also run a jumper from pin 10 of connector P1 to the feedthru that is directly in from the connector.

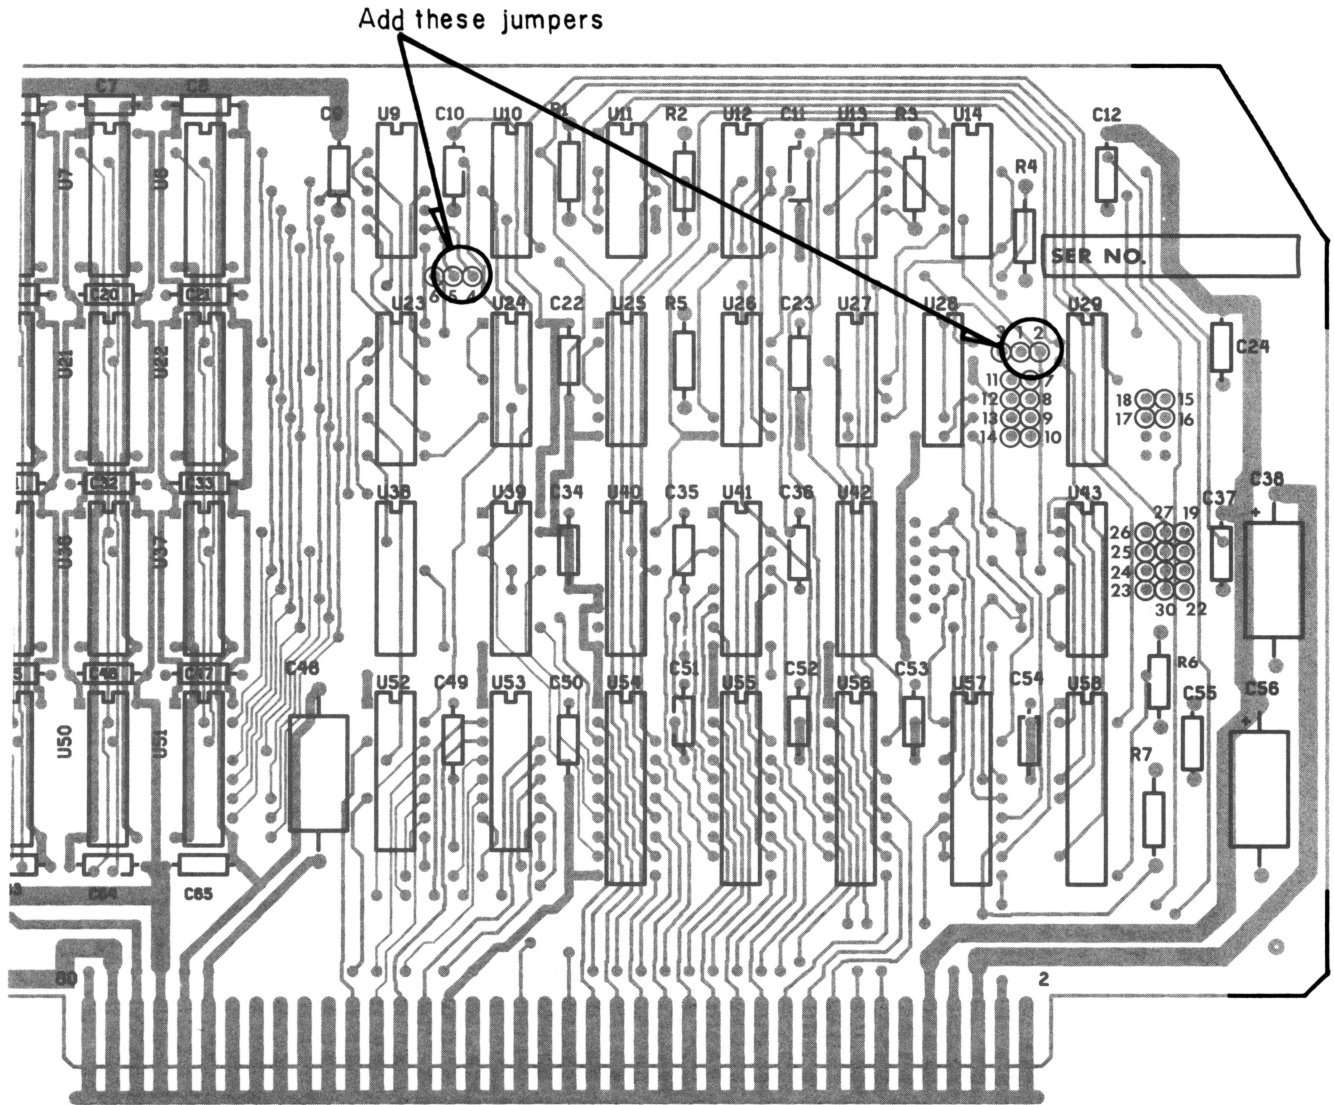
DISCUSSION: Pullups are needed on memory boards for inputs to gates. Intermittent problems can occur without these pullups installed. Some of the Model II memory boards may be missing staking pins for push on connectors and appropriate markings. In this case, use wirewrap to jumper the pads and refer to Figure 1 for pad locations.

PROCEDURE: Check boards for proper jumpering and install jumpers if they are missing. For physical locations of jumpering positions refer to Figure 1 for the memory board and Figure 2 for the Interface board.

Model II Memory boards:
Jumper 1-2 and 5-6
