TECHNICAL BULLETIN INDEX
Sorted by Bulletin Number
06/25/86

DATE: November 5, 1981

BULLETIN NO.: HD:1

PRODUCT: 26-4150

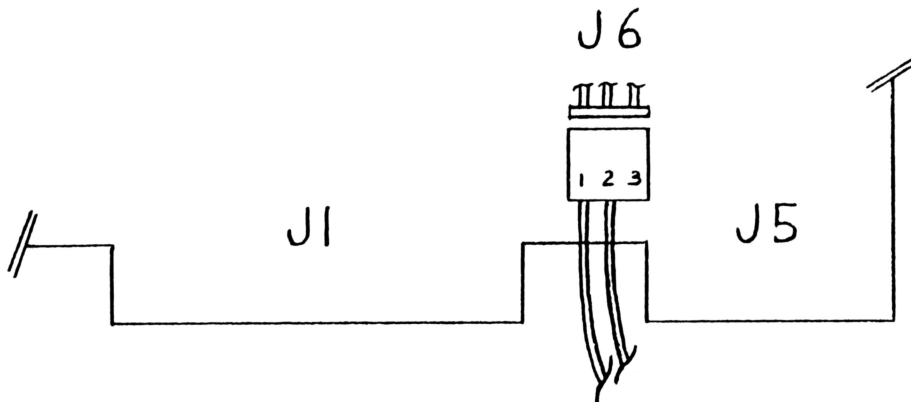
PURPOSE: Due to a mislabeled connector, the index connector could be attached incorrectly and produce drive not ready errors.

DISCUSSION: The connector on some index assemblies (P6) is labeled incorrectly so that pin 1 on the connector does not correspond to pin 1 on the PCB. To avoid this problem make sure that pin 1 on the drive PCB (the one closest to J1) has a wire connected to it by P6. Pin 3 has no wires connected to it. See the drawing below.

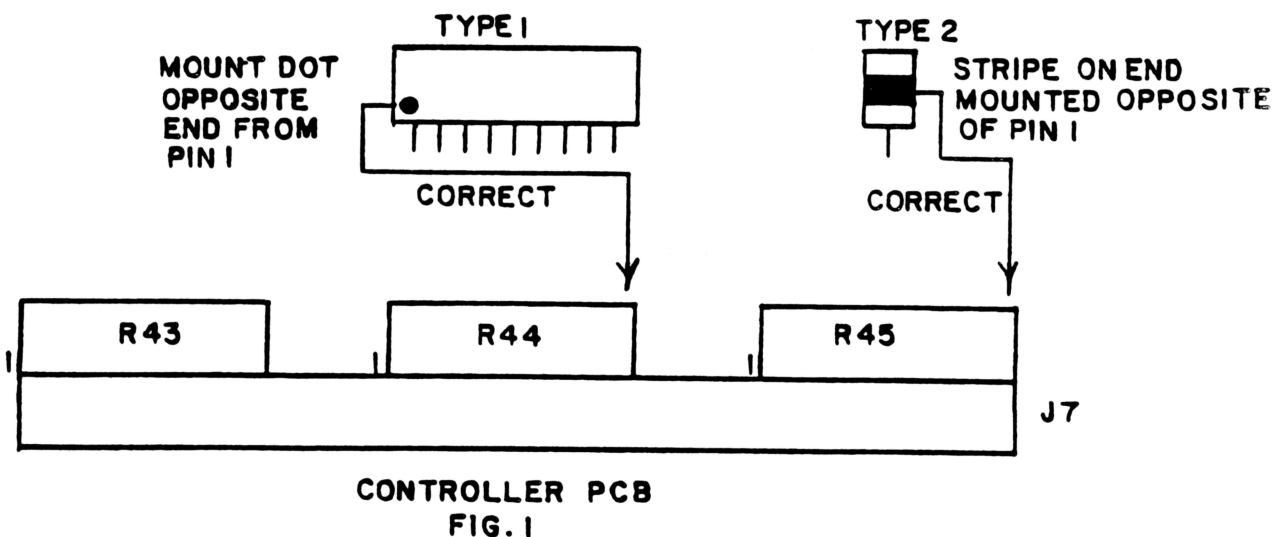
PURPOSE: To correct improper installation of resistor packs on controller PCB.

PROCEDURE: Remove the cover of the primary hard drive and remove the controller board. Locate resistor packs R43, R44, and R45 adjacent to connector J7. If the packs are backwards (refer to fig. 1), remove them and replace them with part# ARX-0331 noting correct orientation (see fig. 1).

After remounting the controller board, verify proper operation of the hard drive and reinstall the cover.

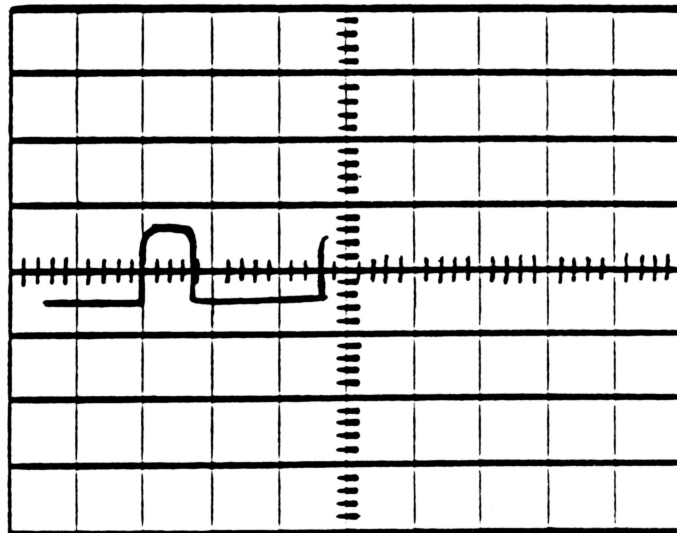
Figure 1

TP8 or U26 pin 37
75 nanosecond high pulse

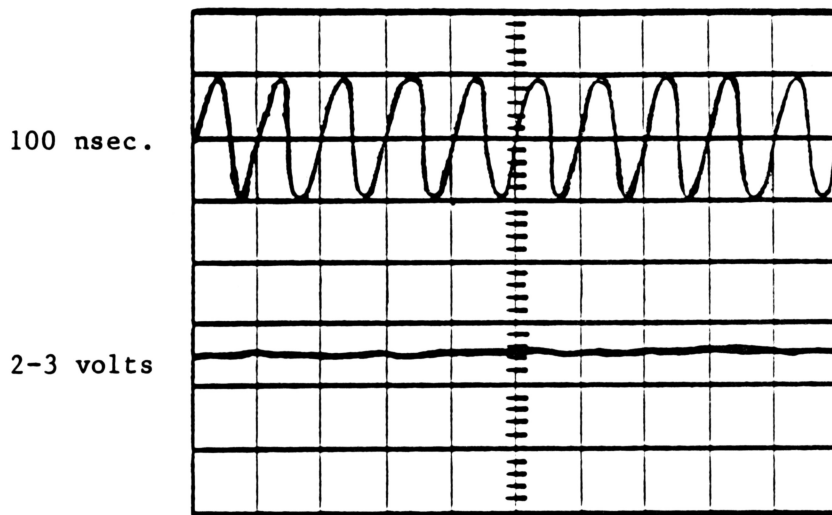
Figure 2

Channel A - 2 volts/division at TP6
 Channel B - 1 volt/division at TP3
 Timebase - 100 nanoseconds/division

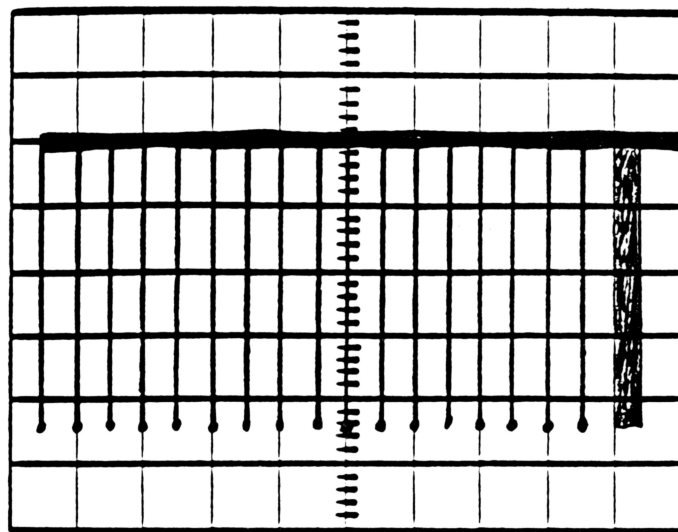
Figure 3

Channel A - 2 volts/division at U19 pin 6 (INDEX)
 Channel B - 1 volt/division at TP7 or U27 pin 15
 Timebase - 2 milliseconds/division

8. Using HDDIAG or HDREL diagnostics, format track 1 then do a continuous read. Adjust R2 until you can distinguish 17 distinct pulses on channel B between the index pulses. Refer to Figure 3. The pass counter on the diagnostic screen should be incrementing with no errors. While reading the track repeat step 6.

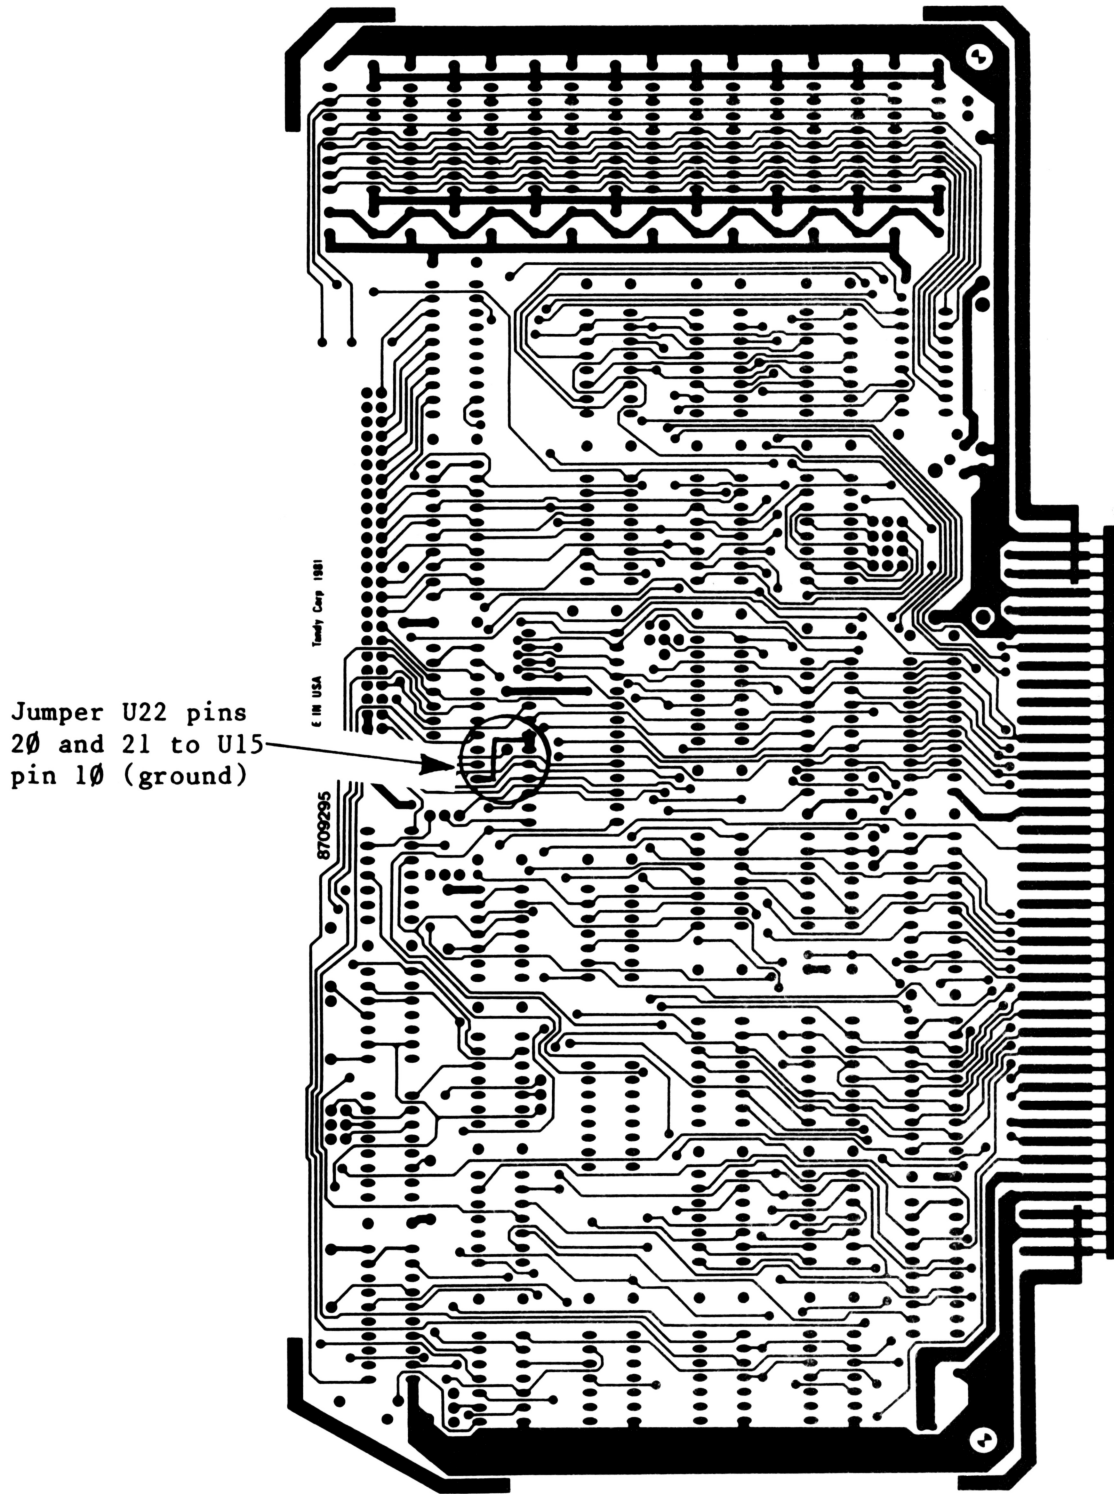
Figure 1

DISCUSSION: Unused CLK/TRG inputs on the CTC chip, when left floating, may cause false triggering of the CTC chip, resulting in system lockup. To prevent this from occurring these inputs need to be grounded. All units in for service **MUST** be checked for this modification.

PROCEDURE: On the foil side of the PCB jumper U22 pins 20 and 21 to U15 pin 10 (Refer to Figure 1).

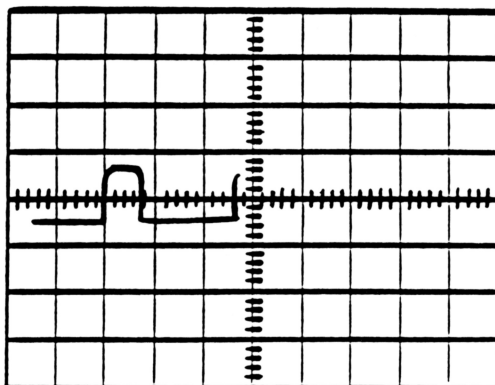
Figure 1

75 - 80 nanoseconds high pulse (TP8)

1. Remove the main units top case cover. This will allow easy access to the controller board.
2. On the controller board, move the jumper plug from E2-E3 to E1-E2.
3. Power up the computer. Attach a scope probe to TP8. Adjust R4 for a 75-80 nanosecond high pulse width. Refer to Figure 1.
4. Attach scope probe to TP3. Adjust R3 until the signal just begins to toggle. This is a preliminary 'DRUN' adjustment and will be made more exact later.
5. Replace the jumper plug to position E2-E3. Set channel A of the scope to 2 volts/division. Set channel B to 1 volt/division and set the timebase to 100 nanoseconds/division. Attach channel A to TP5 and channel B to TP7. Set scope to display both channel A and B.
6. Adjust C8 for a 100 nanosecond wave on channel A (TP5) and 2.0-3.0 volts DC on channel B (TP7). Refer to Figure 2.

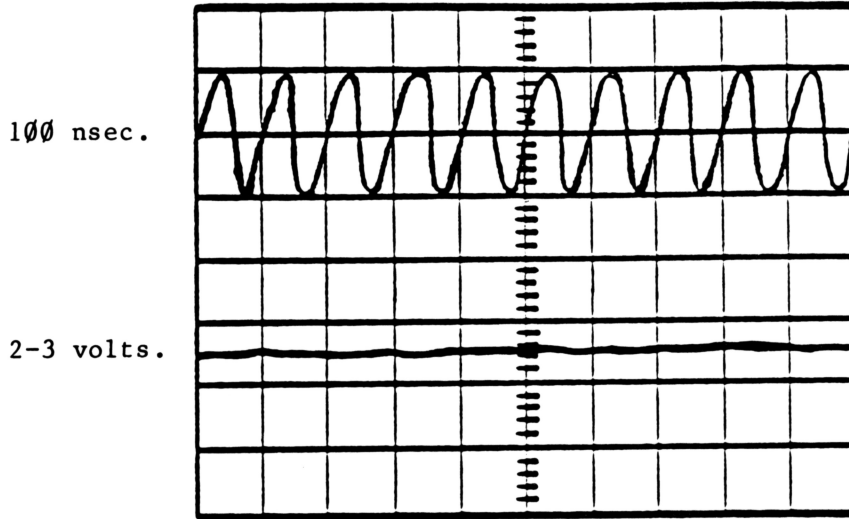
Figure 2

Channel A - 2 volts/division at TP5
 Channel B - 1 volt/division at TP7
 Timebase - 100 nanoseconds/division

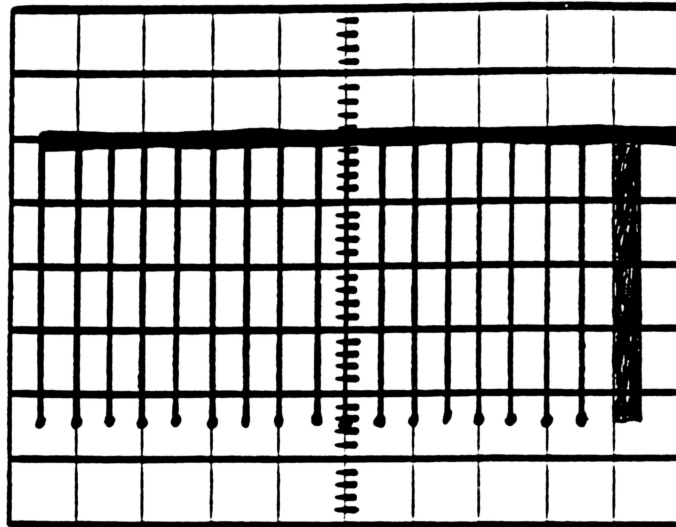
Figure 3

Channel A - 2 volts/division at U18 pin 29 (INDEX)
 Channel B - 1 volt/division at TP3 (DRUN)
 Timebase - 2 milliseconds/division

10. Triggering on channel A adjust R3 until you can distinguish 17 distinct pulses on channel B between the two index pulses on channel A. Refer to Figure 3. The pass counter on the diagnostics screen should be incrementing with no errors. While reading the track repeat step 6.

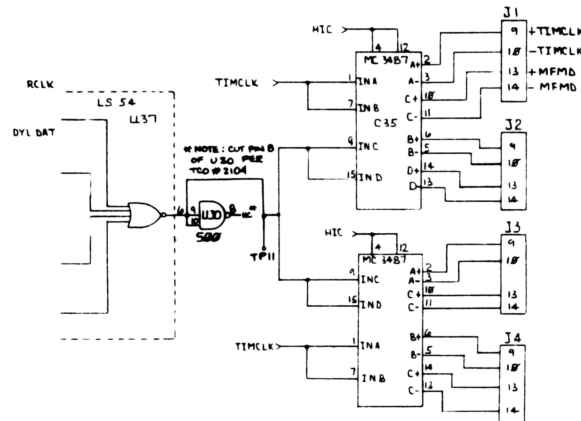
DISCUSSION: As the hard drive writes data to the bubble, it produces "windows", which are nothing more than a timed space for one bit of data to be to be stored. This bit of data is supposed to be in the center of this window to be read accurately. Due to a timing problem, it has been found that this data bit is not always being recorded in the proper place. Therefore the data bit is not in the center of the "window". If this occurs, during a read when a particular window should contain a logic 1, it will be too much to one side or the other, and interpreted as a logic 0, causing data reliability problems. Bypassing the gate in the following procedure, eliminates the timing problem, increasing data reliability.

- 1.) On the **COMPONENT** side of the PCB, cut pin 8 of U30 right at the chip. Cut the pin from the chip, and bend it up.
- 2.) On the **SOLDER** side of the PCB, run a jumper from pin 8, to pin 9 of U30.
