TECHNICAL BULLETIN INDEX
Sorted by Bulletin Number
06/25/86

DATE: January 10, 1983
REVISION DATE: January 10, 1983
BULLETIN NO.: 12/16B:1
PRODUCT: 26-4004/5 (Model 12)
SUBASSEMBLY: Motorola Video Board

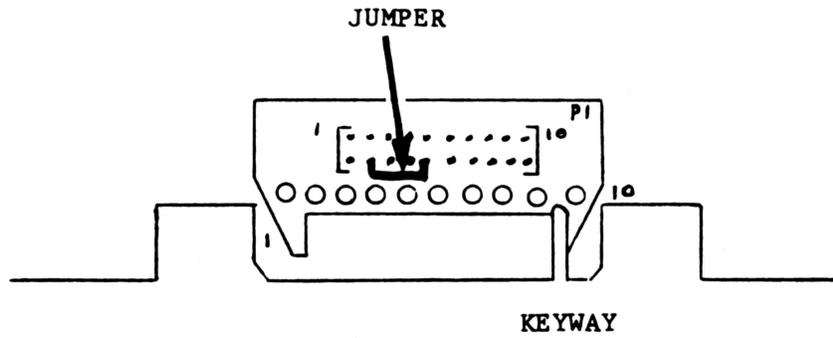
Figure 1

DISCUSSION: The Model 16 can use either an unmodified or modified Motorola video board, although it comes with an unmodified board. The Model 12 **must** use a video board that has been modified with a cut and jumper. This modification allows the video signal from the video/keyboard interface board to be routed through the video driver board on its way to the brightness control. This modification must be done to any Motorola board that is used in a Model 12.

PROCEDURE: The modification consists of a jumper that connects pin 2 of P1 to pin 5 placed in the holes closer to the edge connector as shown in figure 1. Then a cut must be made between the 2 holes in the trace that is connected to pin 2 which will disconnect pin 2 from the rest of the PC board as shown in figure 2.

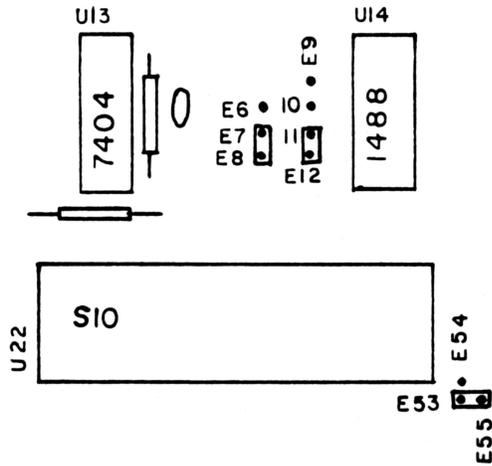
Jumpers for the Main logic board for use with a modem
 Figure 3:

The reason for the two different modifications is that the transmit clock on channel A can cause noise problems when it is connected to the RS232 cable. When a modem is used with the computer this signal can be eliminated which reduces the noise problems. This signal is needed only when a loopback connector is used or two computers are wired directly together without modems.

If it is going to be used with a modem the main logic board should be modified as shown in figure 3 by removing E10-E9. If it is going to be wired directly to another computer it should be left as in figure 2. Also, it is recommended that the customer use a 12 conductor cable on their serial channel instead of a 25 conductor cable.

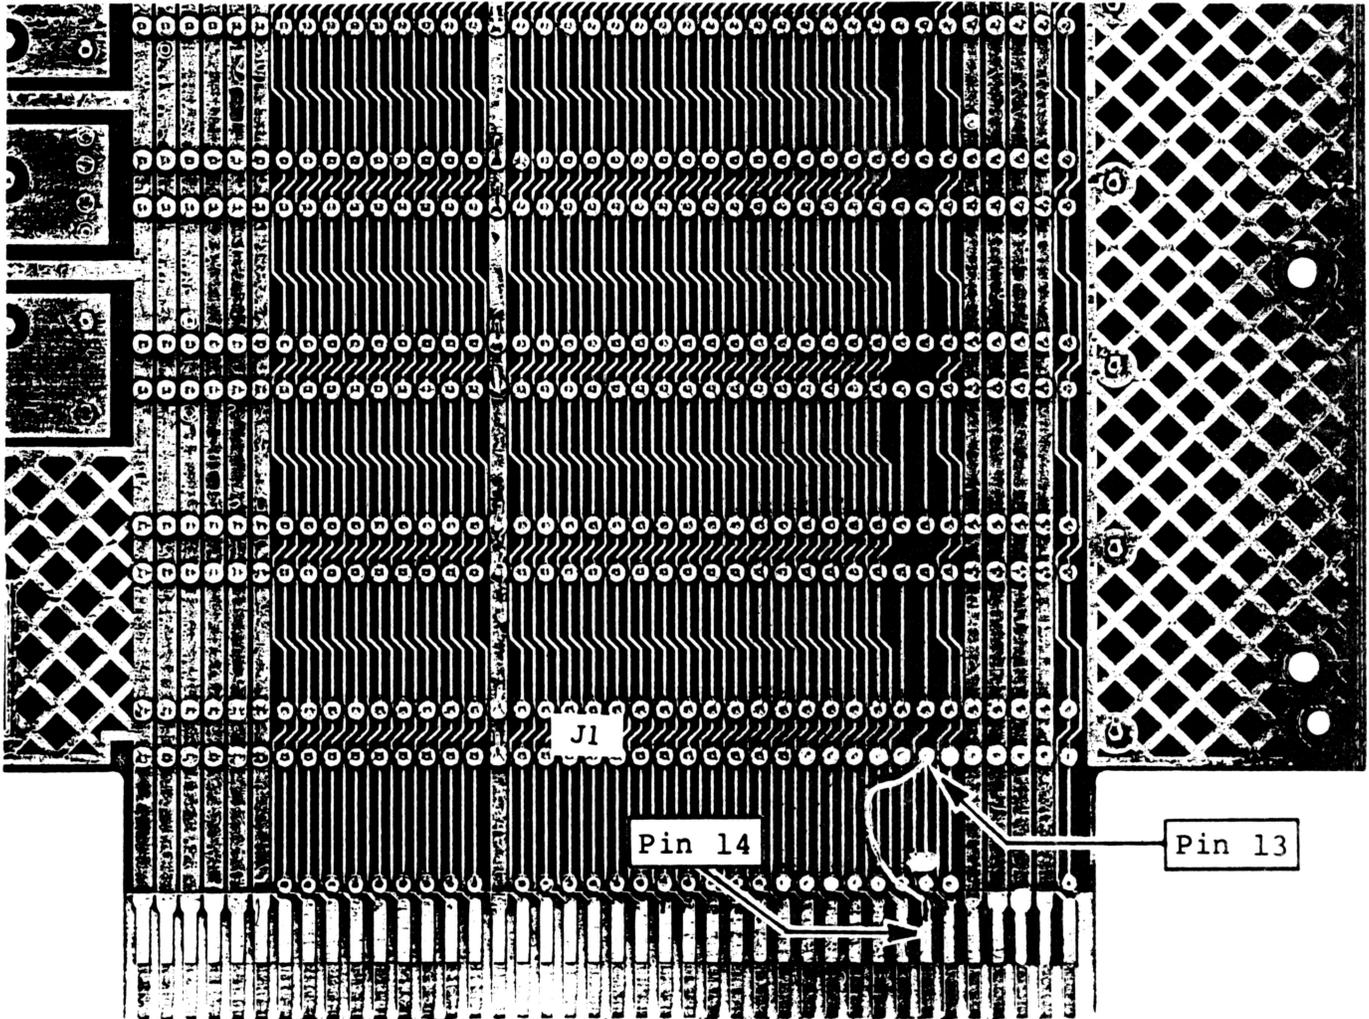
Figure 1

DISCUSSION: An error in the artwork of the mother board (revision PP4), will cause the 1st slot of the mother board to not function properly when a board using Z-80 family interrupts is installed.

PROCEDURE: Just above the point where the mother board plugs into the main logic board cut the two traces going to pins 13 and 14 of the plug (figure 1). Then run a jumper from pin 14 of the plug that goes into the mother board to pin 13 of the first socket in the mother board (J1).

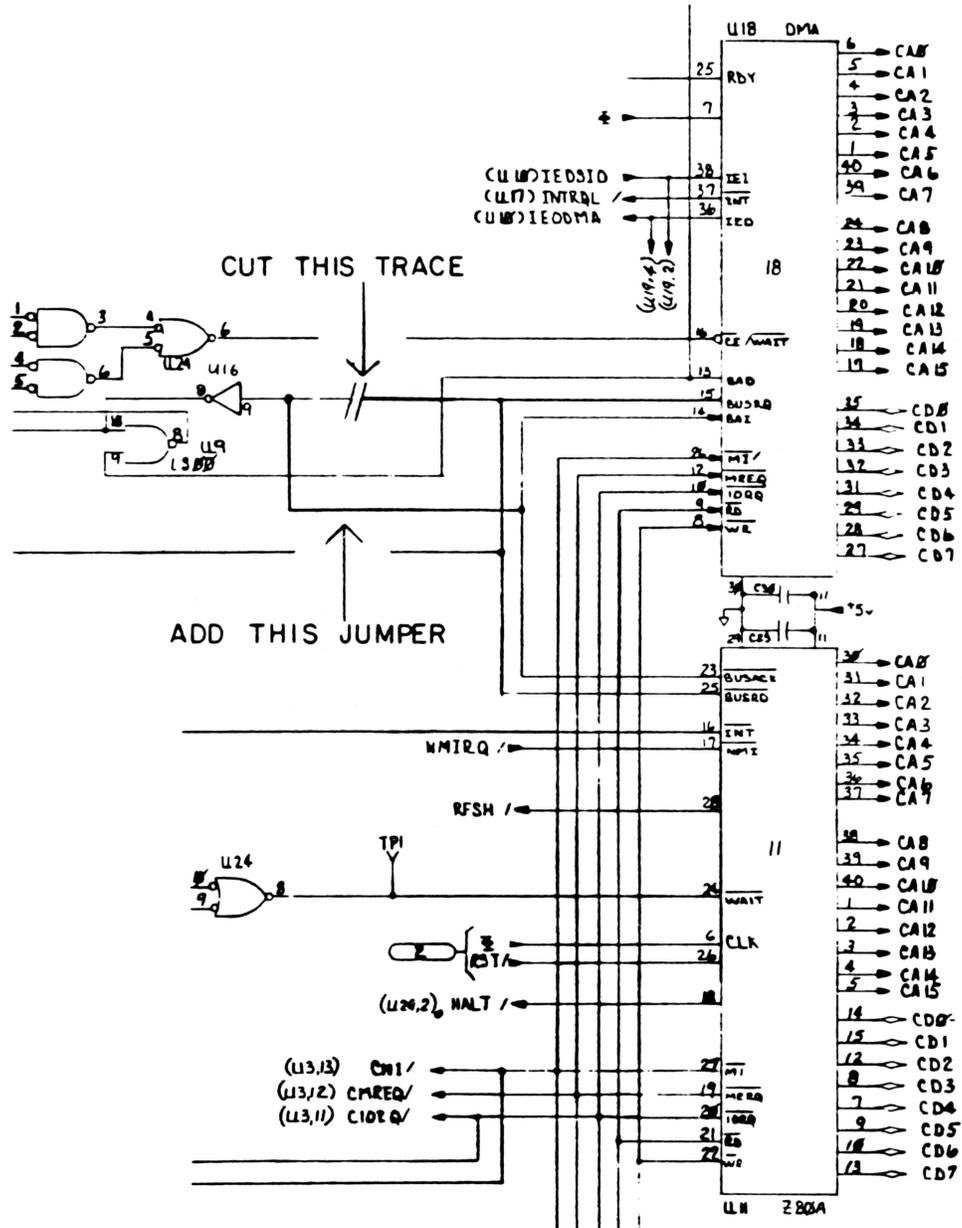
The DMA is being inadvertently selected at times causing 'garbage' to be written to the control registers. The modification described below will keep the DMA from being selected and will keep the Model 12/16B from locking up. **This modification applies to all Model 12/16B's with a Rev. PP3 or Rev. Blank main logic board.**

Cut the trace connected to U16, pin 9 right at the pin on the solder side of the board. Then connect a jumper from U16, pin 9 to the feedthrough connected to U11, pin 23.

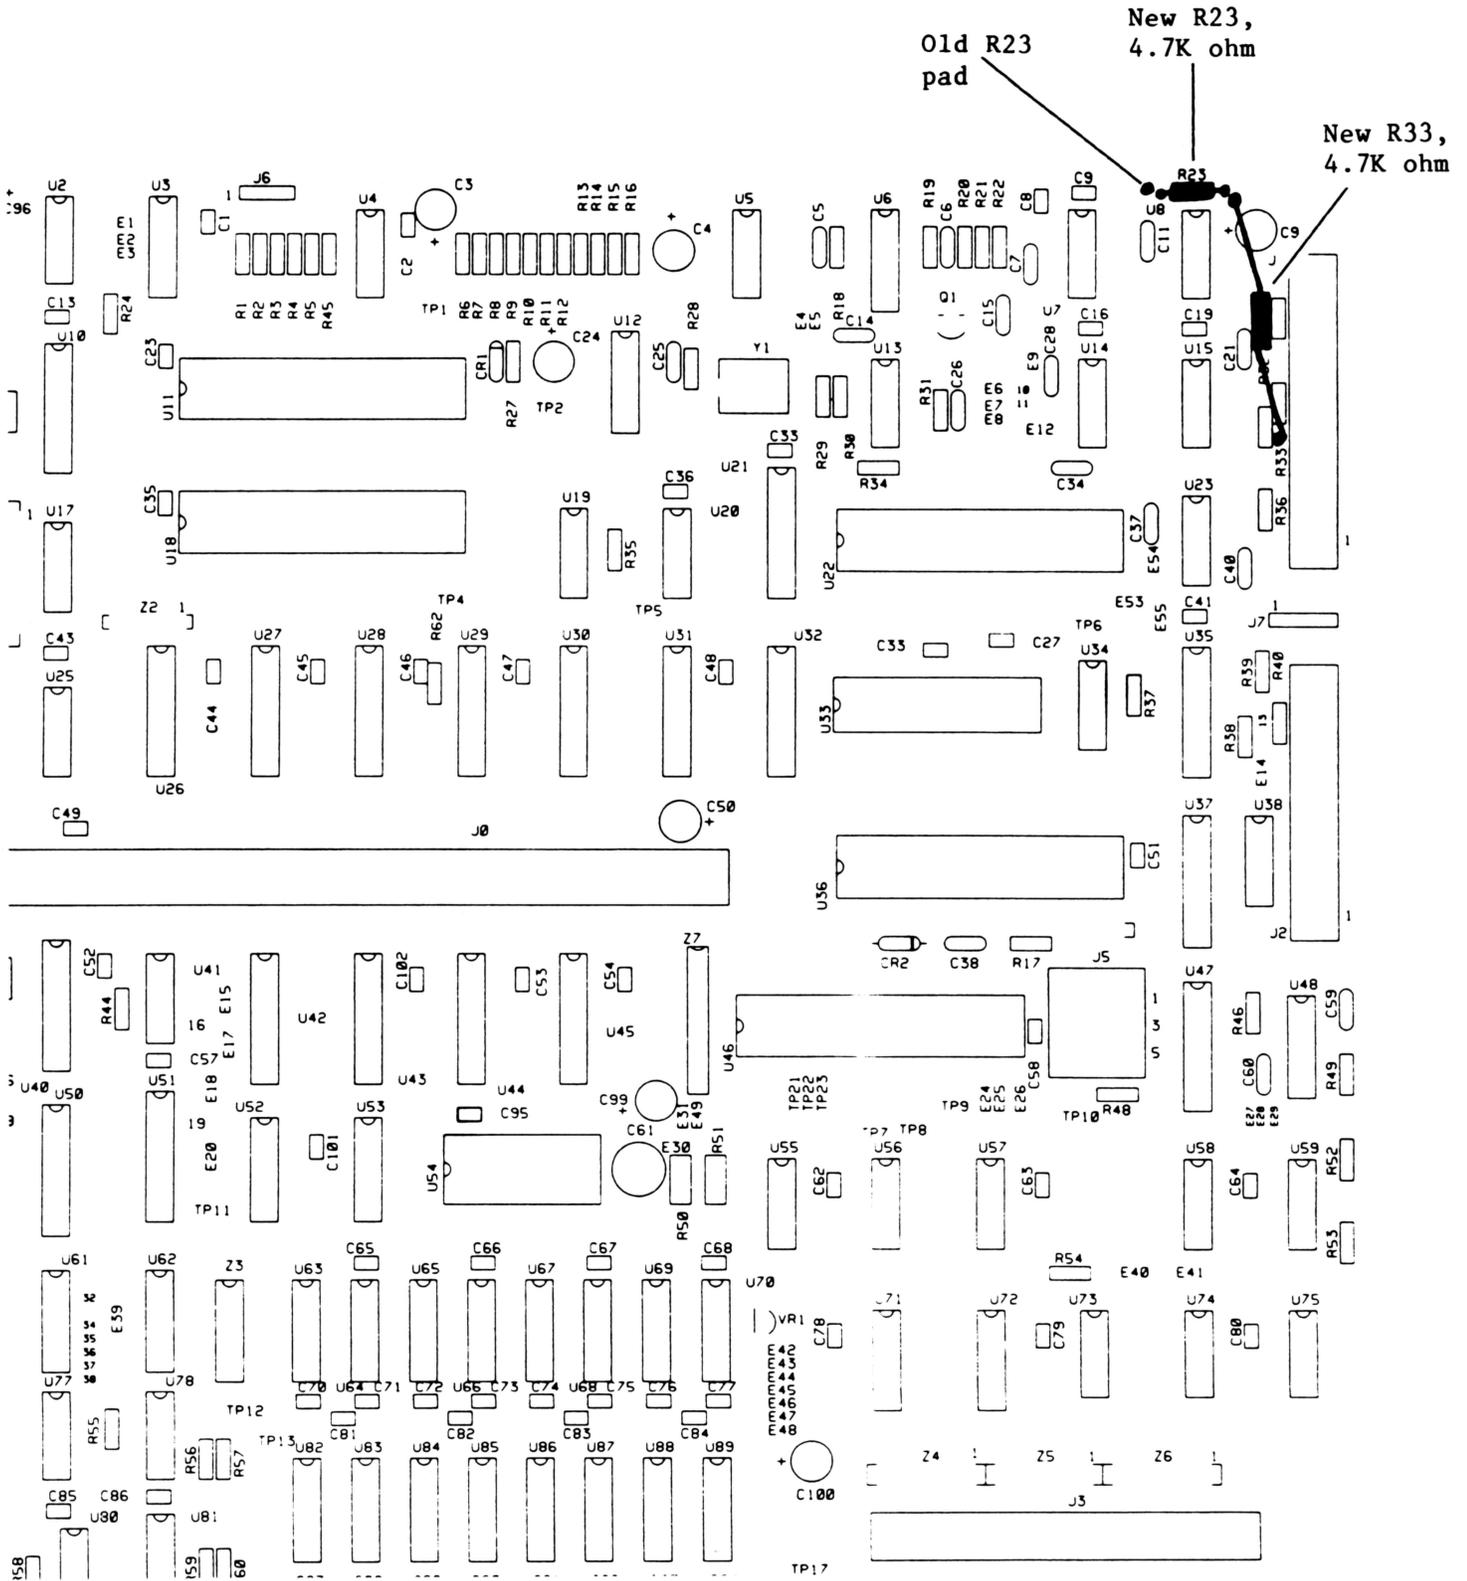
PURPOSE: Modification to make carrier detect signal normally true and guarantee fail-safe signal level for SIO control signals. This modification may also correct problems with systems which will not initialize port B terminals in Xenix operation.

Remove resistor R23. On the component side of the board, install a 4.7K ohm resistor with one lead attached to the old R23 solder connection closest to C97, and the other lead attached to the +12V line at the feedthrough adjacent to the remaining R23 solder connection. The +12V line in question also connects directly to U7, pin 14 (refer to figure 1).

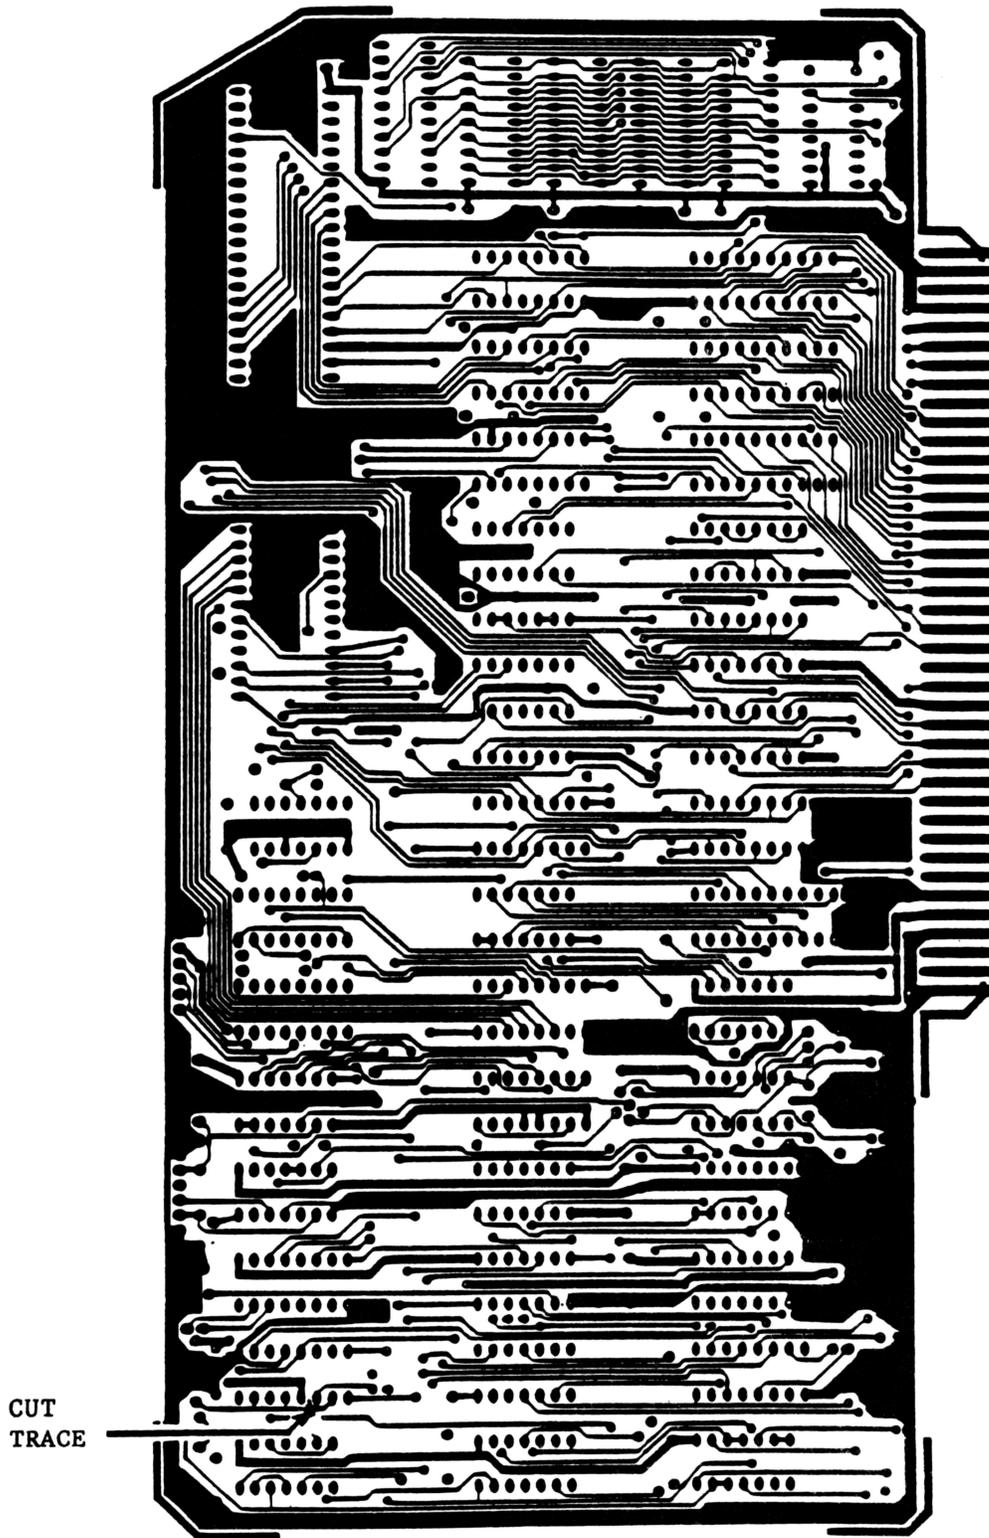
Figure 1 Video PCB (component side)

High memory addresses are shared by the Video and the 64K RAM. When the computer needs to use the video, it will activate the video RAM select logic allowing access to it. Occasionally when doing very fast RAM switching such as diagnostics, due to the access time specification of the RAM, the data transfer may not be reliable causing video failures. To correct this change the video select timing from 10ns to 100ns.

Refer to Figure 1 and cut the trace on the component side at U32 pin 7. Add a jumper wire from U32 pin 7 to U32 pin 12.

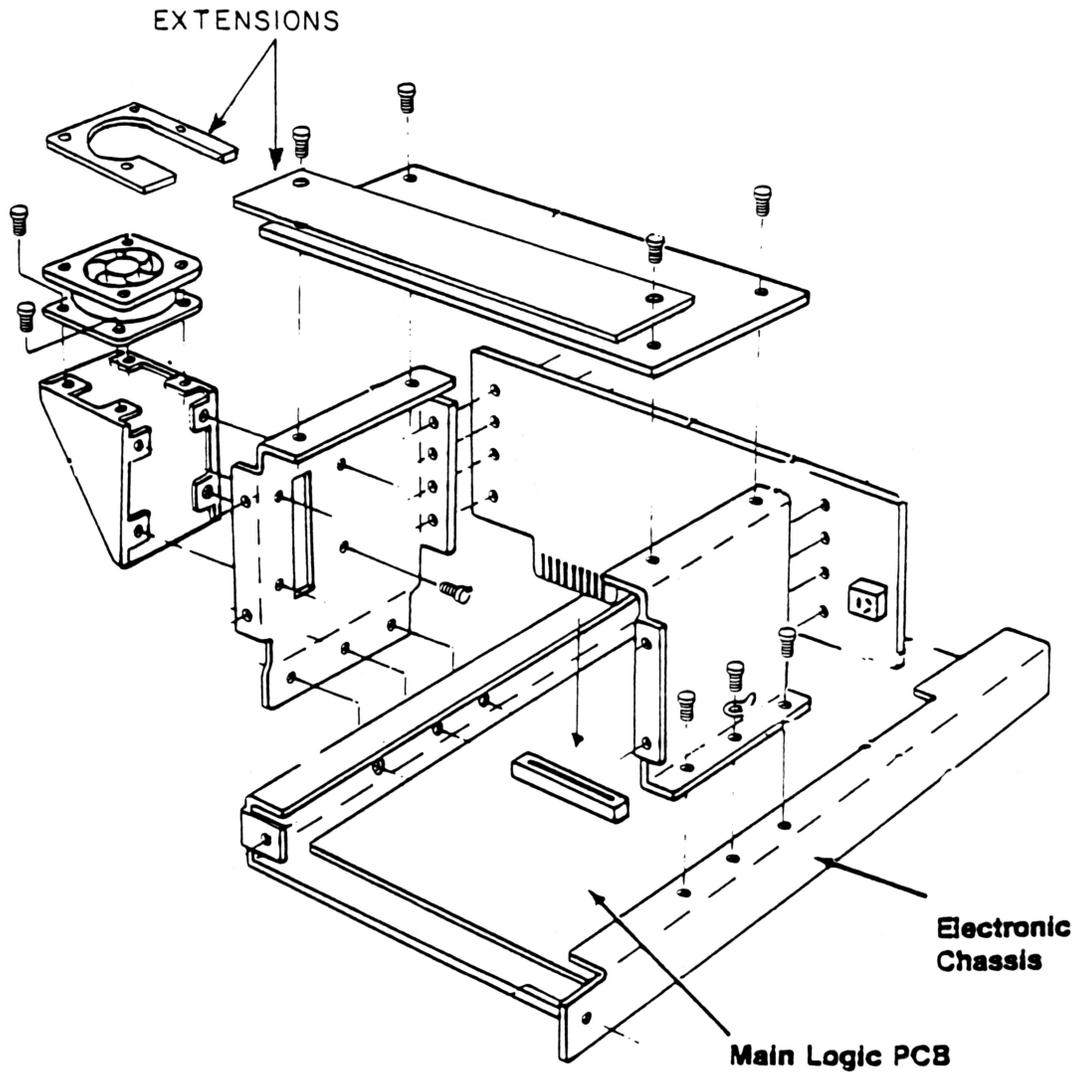
Figure 1

Due to continuous breaking of the guides and the unsecure fit of the circuit boards, the metal card guides in the card cage need to be replaced with plastic guides.

2. Remove the 6 screws that hold the card cage to the chassis. Disconnecting the motherboard power plug and the fan wires will allow the card cage assembly to be pulled up and removed.
 3. Remove the top plate, fan flume, and motherboard.
 4. Replace the left and right side plates with the corresponding part numbers listed above.
 5. Reassemble the card cage and the computer and check for proper operation.
-

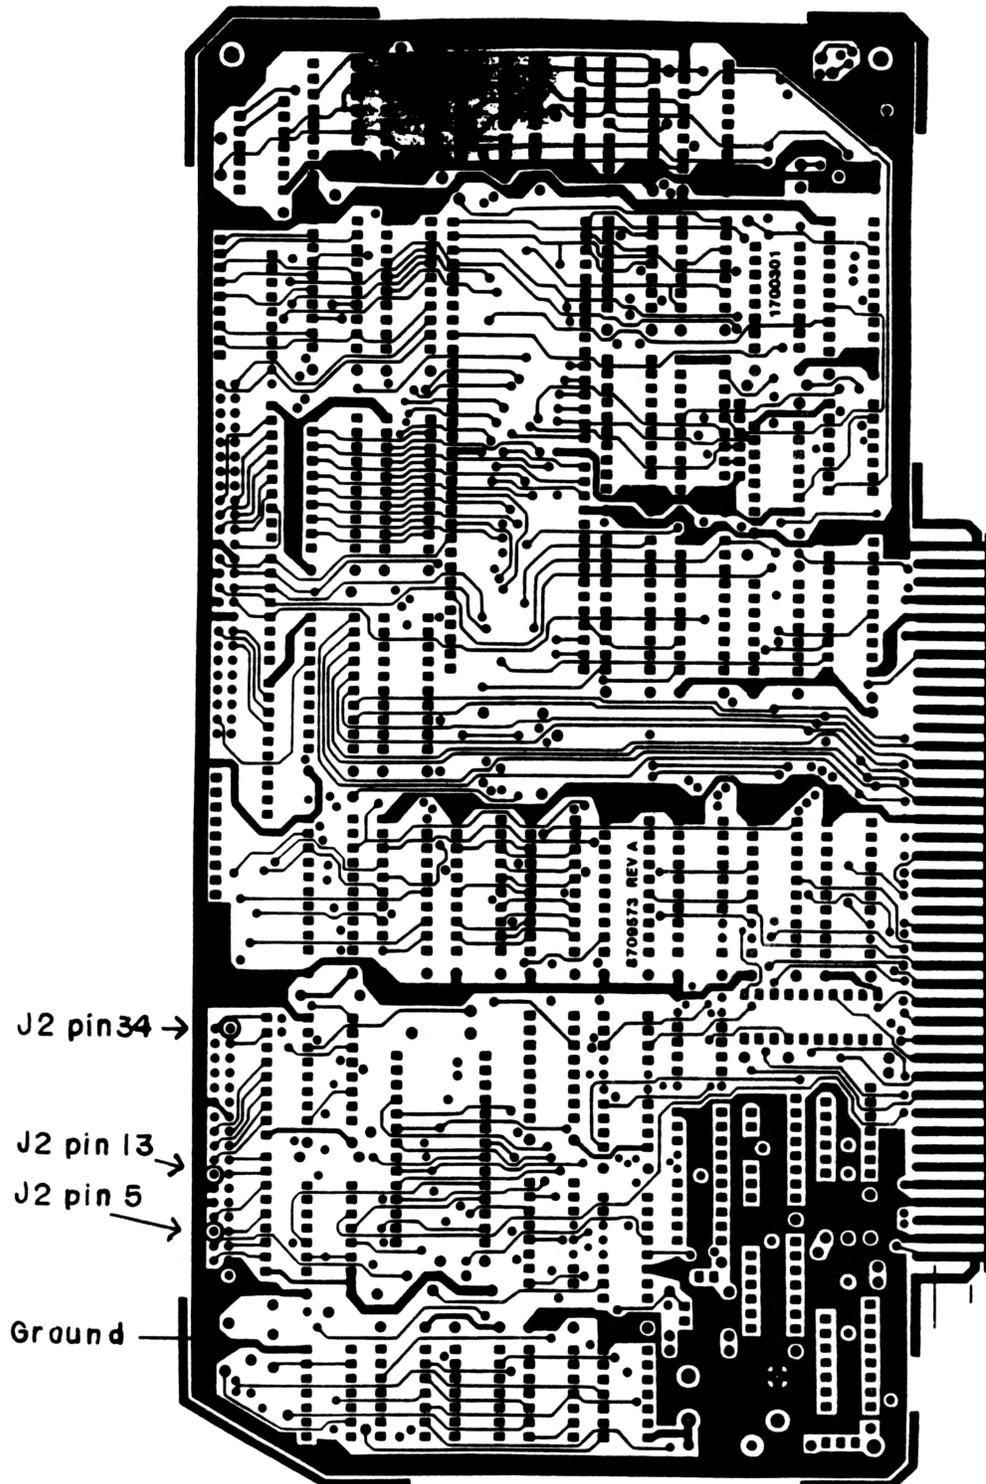
SOLDER SIDE (LAYER 4)

A timing error has been found involving signals BERR* and DTACK* on the 8 MHz 68000 CPU board.

- (1) Jumper J2, pin 5 to ground.
- (2) Jumper J2, pin 13 to ground.
- (3) Jumper J2, pin 34 to ground.

Ground may be found at the feed-throughs on the ground plane near J2 on the solder side on the board.

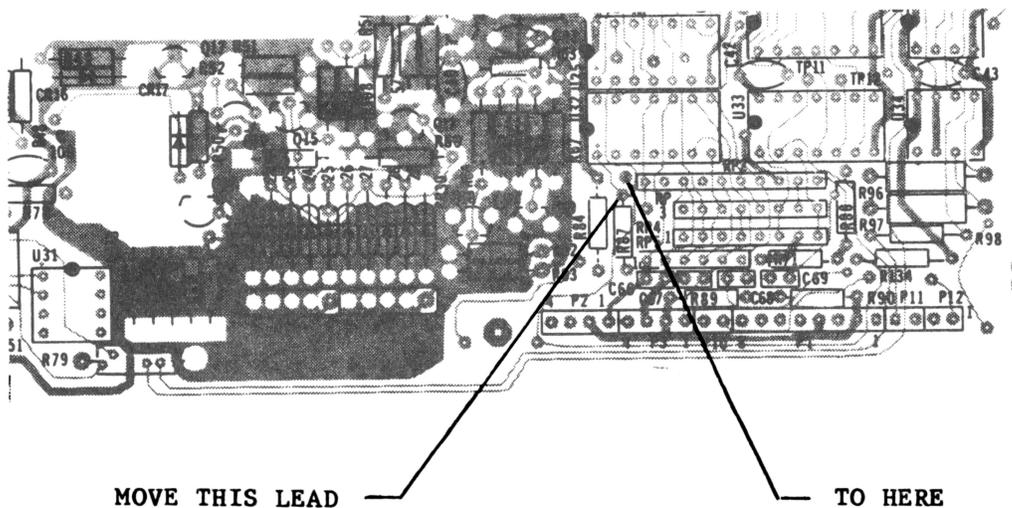
DISCUSSION: Some Tandon Belt Drive Logic Boards (Rev. Y) have come from the vendor with R87, a 150 ohm pullup resistor, installed incorrectly. These boards may be identified by the existence of a small white sticker (bearing a bar code, three numbers, and the letter "Y") attached to the board right next to the "REV" marking. The defective boards will not see the index pulses at all and will not recognize an inserted diskette, i.e. will remain at the "Insert Diskette" prompt even after a diskette is inserted and the drive door is closed.

PROCEDURE: Locate R87 on the Drive Logic Board. Note that one lead is connected to a feedthrough which has a trace running to U32, pin 1. Unsolder this lead of R87 and resolder it to the feedthrough right above it. The correct feedthrough is a +5V trace.
