TECHNICAL BULLETIN INDEX
Sorted by Bulletin Number
06/25/86

DATE: January 16, 1985
REVISION DATE: February 13, 1985
BULLETIN NO.: 6000:1
PRODUCT: 26-6021/2 (Tandy 6000)
26-6014 (8 MHz CPU upgrade kit)
SUBASSEMBLY: 8 MHz 68000 CPU board

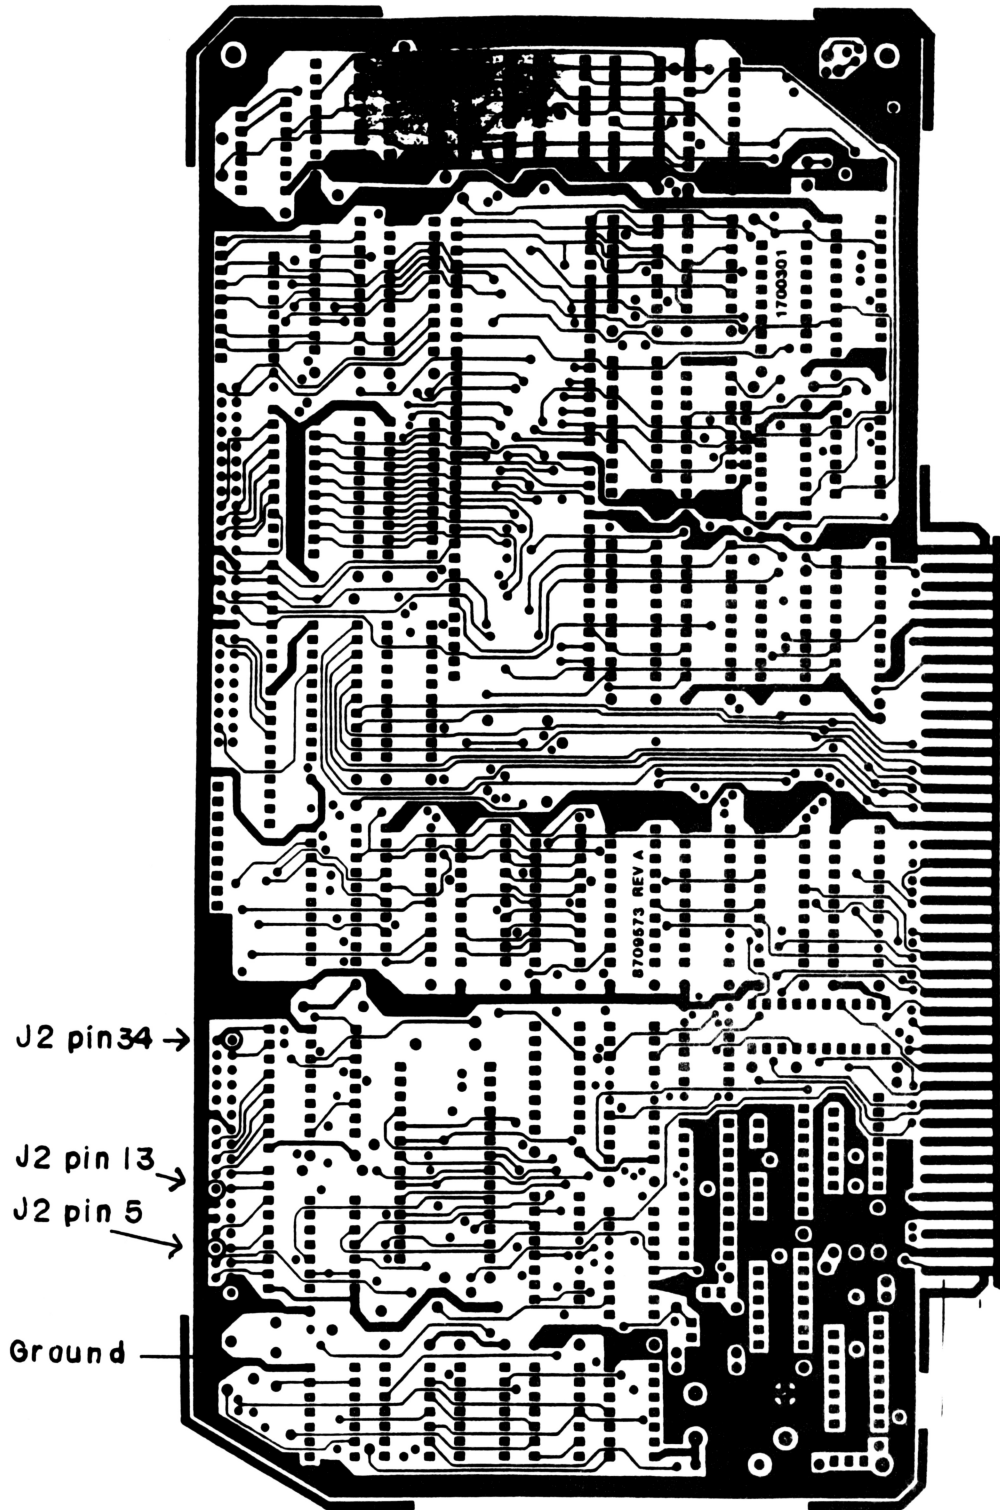
SOLDER SIDE (LAYER 4)

Due to an error in the artwork on early revision (Revision A) boards, a modification to insure good ground connections between the 68000 CPU board and associated memory boards is required.

Ground may be found at the feed-throughs on the ground plane near J2 on the solder side on the board.

Using wire wrap wire, install the following jumpers on the solder side of the 68000 CPU board:

- (1) Jumper J2, pin 5 to ground.
- (2) Jumper J2, pin 13 to ground.
- (3) Jumper J2, pin 34 to ground.

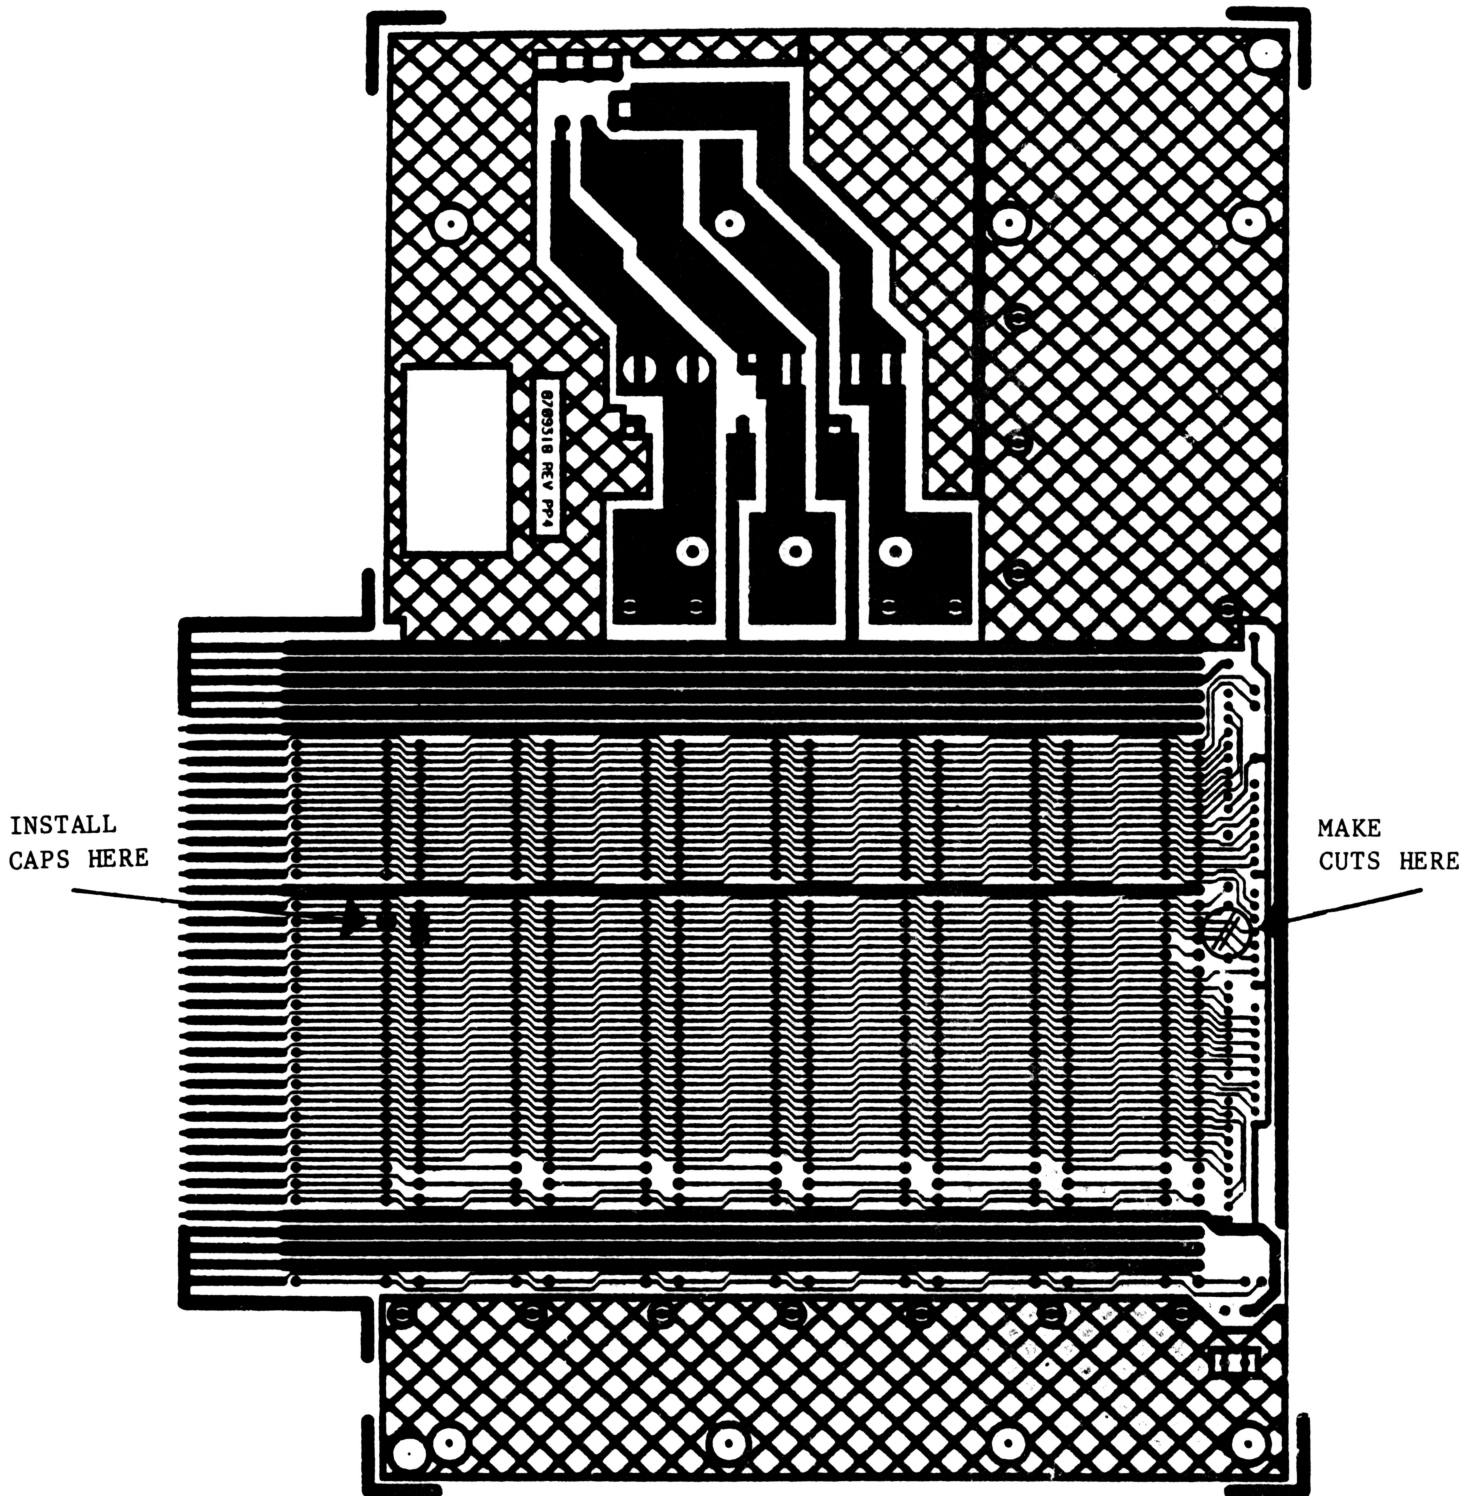
To prevent bus errors, three traces need to be cut away from a resistor pack and three capacitors need to be installed on the card cage mother board.

On mother boards of revision levels prior to Rev. B, pins 3, 4, and 5 on resistor pack R6 need to be cut.

On mother boards of revision level Rev. B or later, pins 4, 5, and 6 on resistor pack R6 need to be cut.

On boards of all revision levels, three (3) 220 pf caps should be jumpered from pins 44, 45, and 46 to ground on the bottom-most connector. These pins correspond to the traces cut on the resistor pack R6. See Figure 1 for clarification. The capacitors needed for this modification may be ordered as:

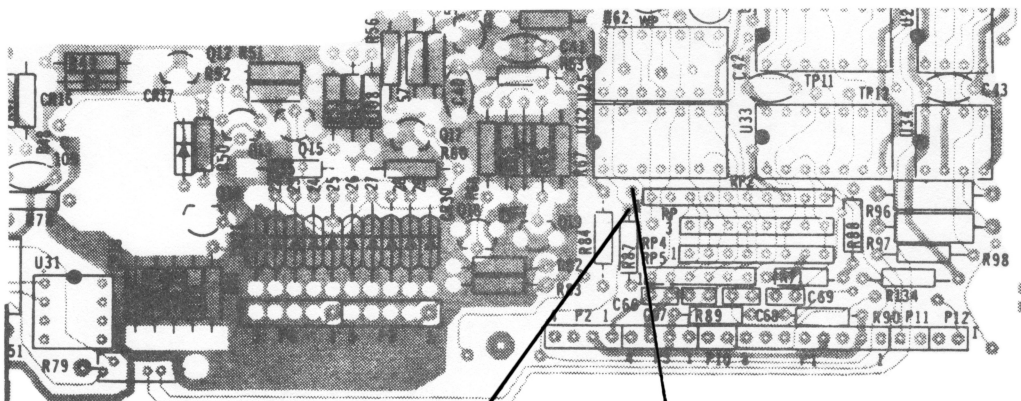
DISCUSSION: Some Tandon Belt Drive Logic Boards (Rev. Y) have come from the vendor with R87, a 150 ohm pullup resistor, installed incorrectly. These boards may be identified by the existence of a small white sticker (bearing a bar code, three numbers, and the letter "Y") attached to the board right next to the "REV" marking. The defective boards will not see the index pulses at all and will not recognize an inserted diskette, i.e. will remain at the "Insert Diskette" prompt even after a diskette is inserted and the drive door is closed.

MOVE THIS LEAD ————— TO HERE

PROCEDURE: Locate R87 on the Drive Logic Board. Note that one lead is connected to a feedthrough which has a trace running to U32, pin 1. Unsolder this lead of R87 and resolder it to the feedthrough right above it. The correct feedthrough is a +5V trace.

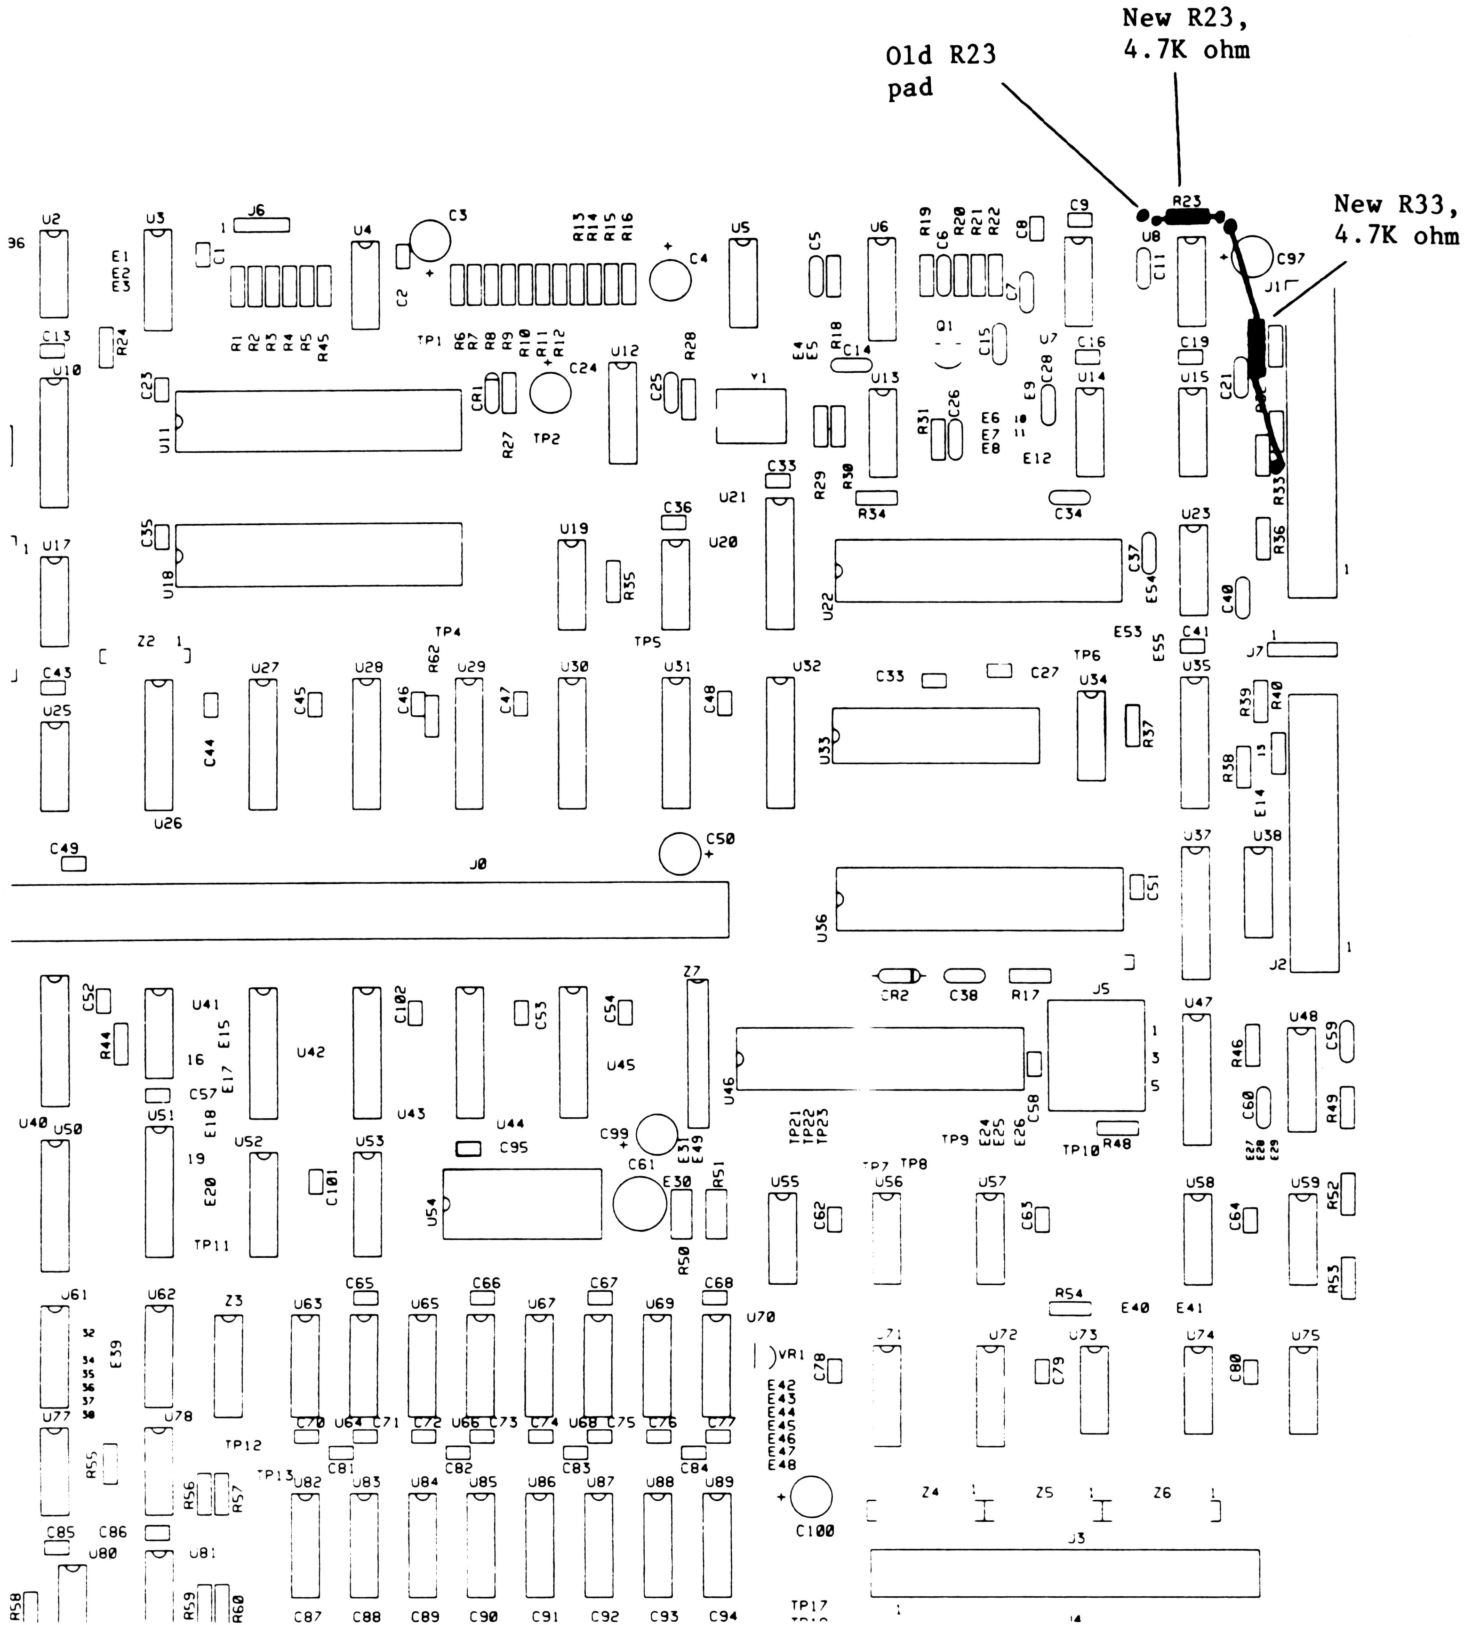
To make the serial ports more reliable the pullups for SIO control signals need to be changed. The pullup for carrier detect needs to be changed not only in value, but from -12V to +12V so that it is normally true. This modification is required on all Rev. Blank boards.

On some boards which display problems initializing port B in Xenix operation (i.e. boards which refuse to communicate with terminals on port B), an additional modification may be necessary, which pulls carrier detect normally true on port B as well as on port A. This modification may be necessary on both Rev. Blank and Rev. A main logic boards.

Change R21, R23, R25, R32, R36 from 10K ohm to 4.7K ohm resistors. Remove resistor R33. On the component side of the board, install a 4.7K ohm resistor with one lead attached to the old R33 solder connection closest to R36 and the other lead attached to the +12V line at the feedthrough adjacent to R23 between U8 and C97 (refer to figure 1). The leads should be insulated to prevent them from shorting.

Remove resistor R23. On the component side of the board, install a 4.7K ohm resistor with one lead attached to the old R23 solder connection closest to C97, and the other lead attached to the +12V line at the feedthrough adjacent to the remaining R23 solder connection. The +12V line in question also connects directly to U7, pin 14 (refer to figure 1).
