TECHNICAL BULLETIN INDEX
Sorted by Bulletin Number
06/25/86

DATE: November 5, 1981

BULLETIN NO.: HD:1

PRODUCT: 26-4150

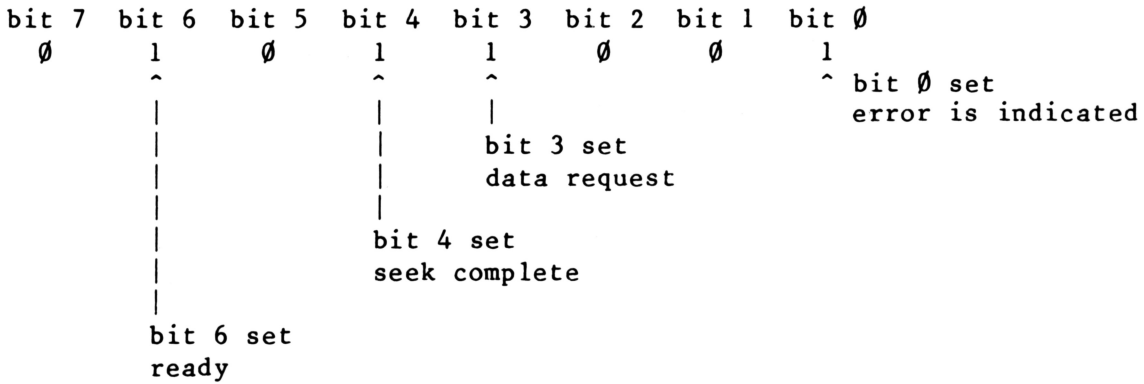
Now convert the status registers bits:

59 hex = 01011001 binary

Knowing the contents of these registers may not tell you exactly where the problem is, but it can be helpful in troubleshooting.

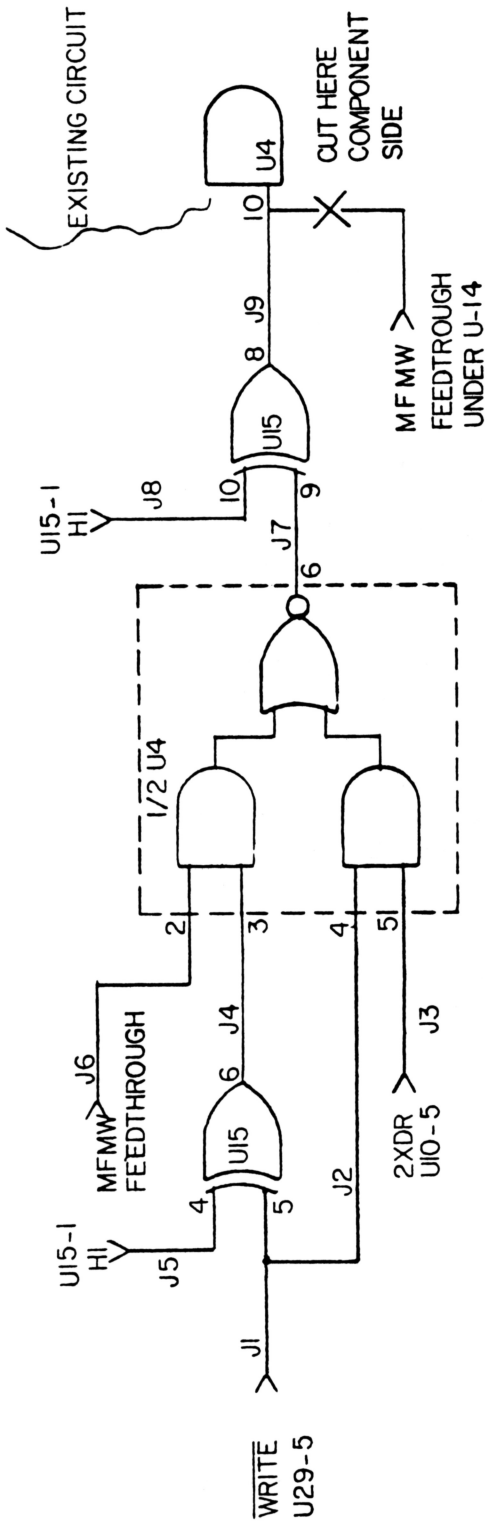
CIRCUIT DIAGRAM

PURPOSE: Mandatory modification to correct VCO failures.

DISCUSSION: During power-up and idle conditions, the VCO attempts to lock onto a 10 MHZ signal. In early hard drive controllers, only a 5 MHZ signal is available during this period causing the VCO to try to lock on to a harmonic. This results in unreliable operation. This modification will provide the VCO with a 10 MHZ clock during idle periods.

Upon completion of the modification, a complete controller board alignment must be performed. Please refer to the hard drive diagnostics for the procedure.
